**Section 10**  
**HYDROLOGY, GEOLOGY AND HYDROGEOLOGY**

## Section 10: HYDROLOGY, GEOLOGY AND HYDROGEOLOGY

10.1.1 Natural Power Consultants Ltd (Natural Power) have undertaken a revised assessment of the potential impacts on geological, hydrological and hydrogeological receptors as a result of the construction and operation of the proposed Scoop Hill Community Wind Farm, located in Dumfries & Galloway, on behalf of Community Windpower Limited (CWL).

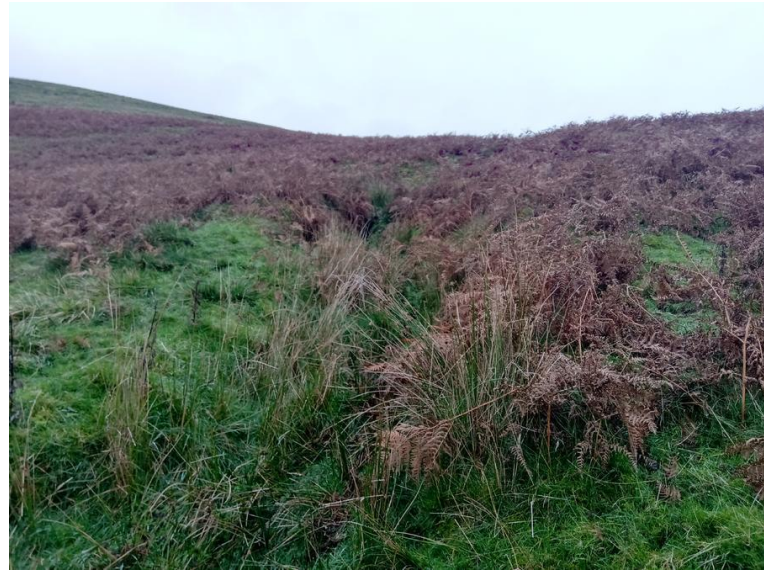
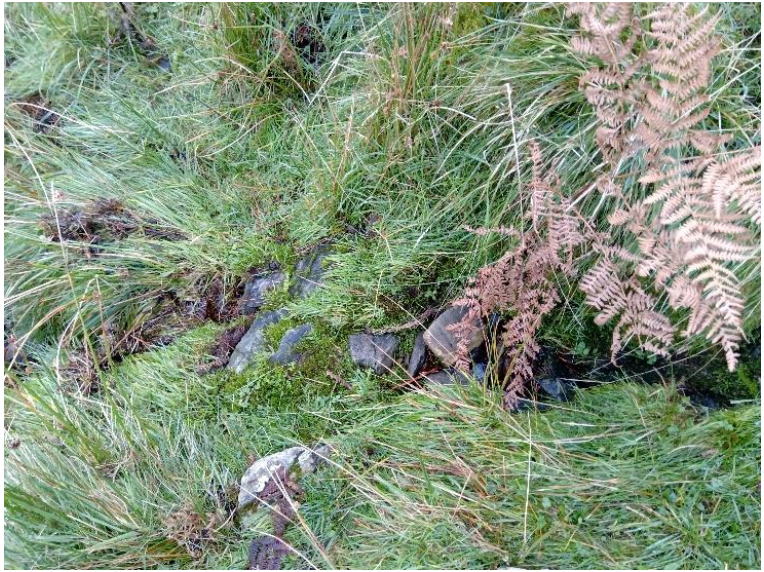
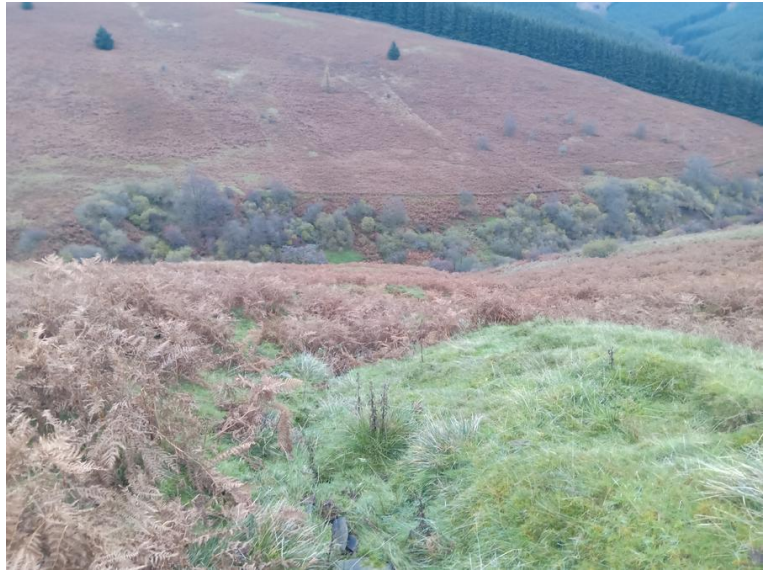
<p>© Crown Copyright 2023. All rights reserved. Ordnance Survey Licence</p>	<p style="text-align: center;"><b>Crossing description</b></p> <p><b>Existing Crossing:</b> No</p> <p><b>Channel Type:</b> Slightly Incised</p> <p><b>Gradient:</b> Steep</p> <p><b>Valley form:</b> No obvious valley sides</p> <p><b>Bank condition:</b> Undercut (no evidence of recent collapse)</p> <p><b>Bed material:</b> Boulders, Coarse gravel, Fine sand/silt</p> <p><b>Riparian corridor:</b> Moorland, Agricultural Grazing</p> <p><b>Flow condition:</b> Dry</p> <p><b>Water width (m):</b> 0.05</p> <p><b>Water depth (m):</b> 0.01</p> <p><b>Bankfull width (m):</b> 0.20</p> <p><b>Bankfull height (m):</b> 0.20-0.30</p> <p><b>Flooded Bankfull width (m):</b> 2.00</p> <p><b>Flooded Bankfull height (m):</b> 0.80</p> <p><b>Notes:</b> Watercourse is not shown on OS 1:50,000 scale digital mapping. It is only shown on the OS 1:25,000 and therefore no authorisation under the CAR is required. GBR will apply</p> <p><b>CAR Auth Level:</b> GBR</p> <p><b>Proposed Crossing Type:</b> Circular pipe</p>

<b>Crossing Photographs</b>		
<p style="text-align: center;"><b>Upstream</b></p>

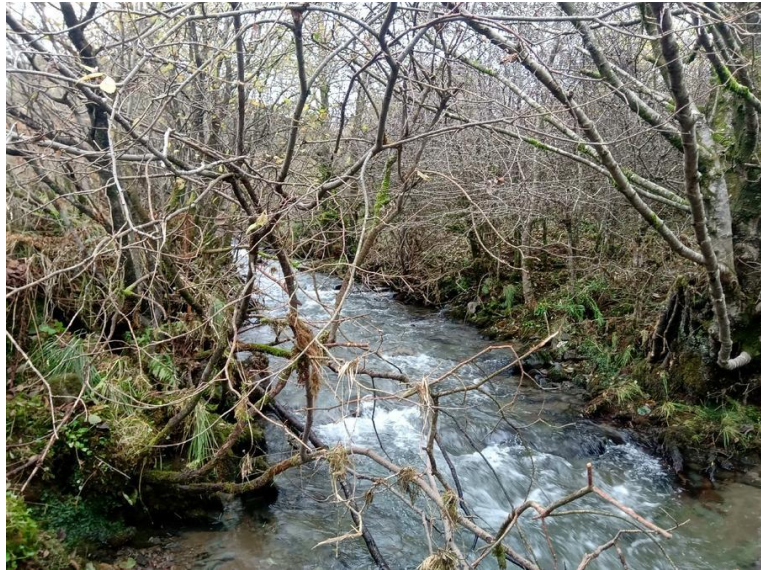
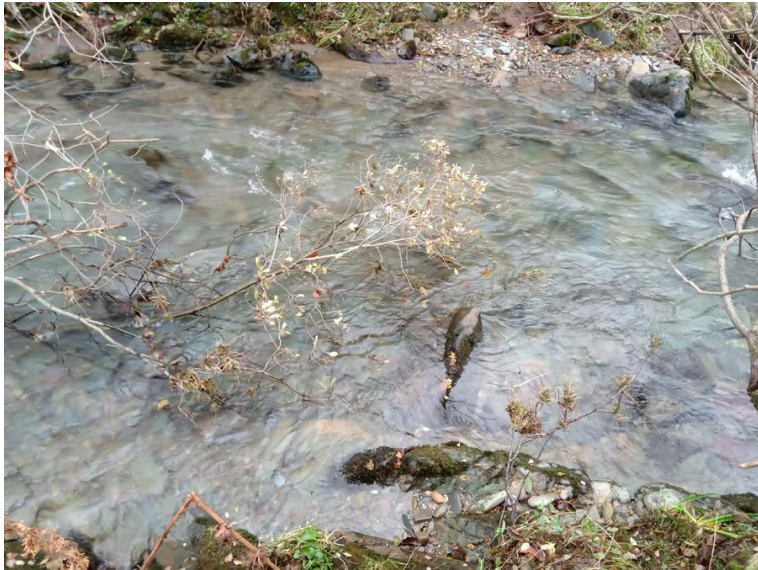
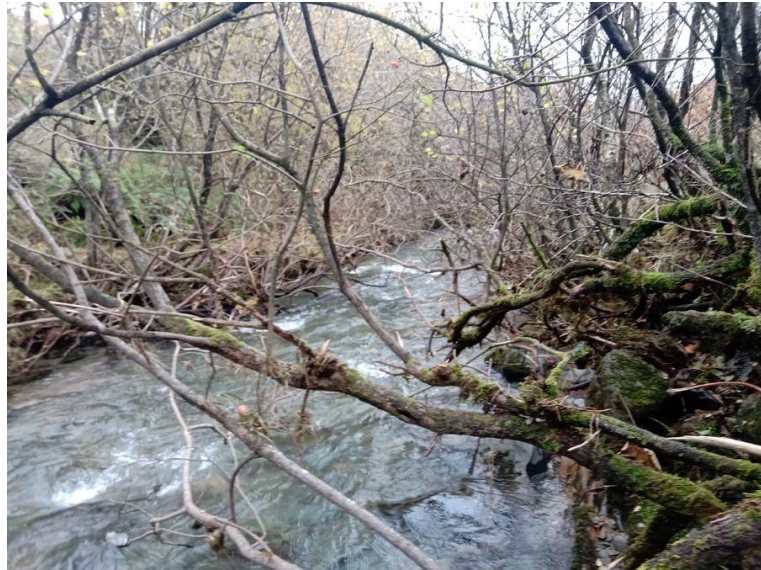
**Table 10.3: Watercourse crossing WC50**

<p>© Crown Copyright 2023. All rights reserved. Ordnance Survey Licence</p>	<p><b>Existing Crossing:</b> No</p> <p><b>Channel Type:</b> Meandering (channel straight at point of crossing)</p> <p><b>Gradient:</b> Gentle</p> <p><b>Valley form:</b> Vee</p> <p><b>Bank condition:</b> Slight undercut (no evidence of recent collapse), Stable</p> <p><b>Bed material:</b> Sand/silt, Rounded pebbles, Boulders, Bedrock</p> <p><b>Riparian corridor:</b> Agricultural Grazing, Heavily Vegetated (e.g. gorse, bramble), Natural Woodland, Commercial Forestry</p> <p><b>Flow condition:</b> Moderate</p> <p><b>Water width (m):</b> 3.00</p> <p><b>Water depth (m):</b> 0.30-0.40</p> <p><b>Bankfull width (m):</b> 4.50</p> <p><b>Bankfull height (m):</b> 0.90</p> <p><b>Banktop height (m):</b> 1.2 (left bank looking upstream)</p> <p><b>Flooded Bankfull width (m):</b> 5.00</p> <p><b>Flooded Bankfull height (m):</b> 1.20</p> <p><b>Note:</b> Small trees/bushes and ferns along bank.</p> <p><b>CAR Auth Level:</b> Simple Licence</p> <p><b>Proposed Crossing Type:</b> Pipe or Box Culvert</p>

<b>Crossing Photographs</b>		
<b>Upstream</b>	<b>Across</b>	<b>Downstream</b>

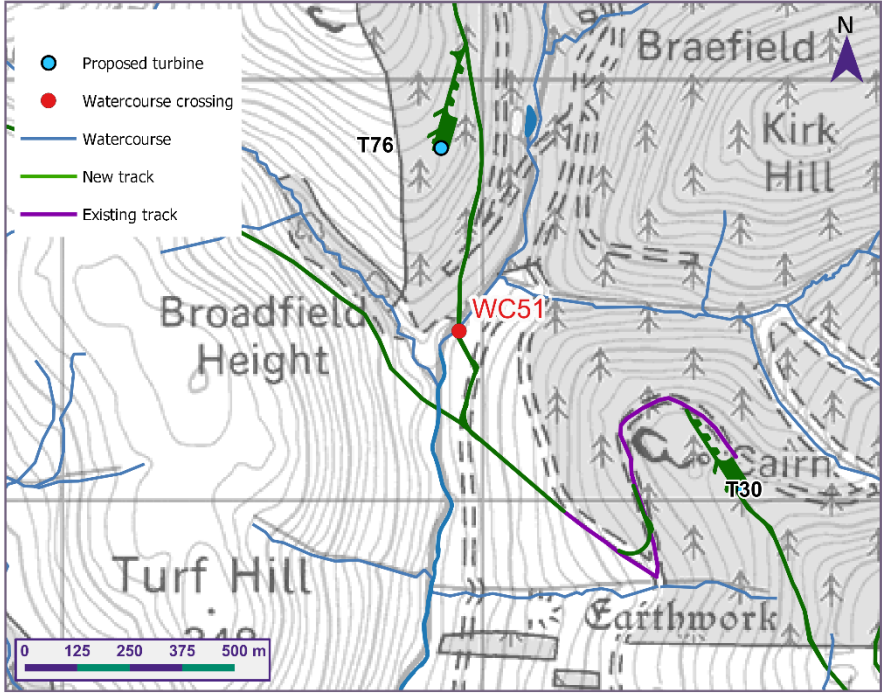
<p>© Crown Copyright 2023. All rights reserved. Ordnance Survey Licence</p>	<p><b>Existing Crossing:</b> No</p> <p><b>Channel Type:</b> Meandering (channel quite straight at point of crossing)</p> <p><b>Gradient:</b> Gentle</p> <p><b>Valley form:</b> Very shallow vee</p> <p><b>Bank condition:</b> Undercut (no evidence of recent collapse)</p> <p><b>Bed material:</b> Boulders, sand/silt, Rounded pebbles</p> <p><b>Riparian corridor:</b> Natural Woodland, Commercial Forestry, Agricultural Grazing</p> <p><b>Flow condition:</b> Moderate</p>	<p><b>Water width (m):</b> 4.00</p> <p><b>Water depth (m):</b> 0.30-0.50</p> <p><b>Bankfull width (m):</b> 4.00</p> <p><b>Bankfull height (m):</b> 0.50</p> <p><b>Banktop height (m):</b> 0.50 bank on left looking upstream is higher.</p> <p><b>Flooded Bankfull width (m):</b> 5.00</p> <p><b>Flooded Bankfull height (m):</b> 0.90</p> <p><b>Note:</b> Small bushes and trees along bank</p> <p><b>CAR Auth Level:</b> Simple Licence</p> <p><b>Proposed Crossing Type:</b> Pipe or Box Culvert</p>

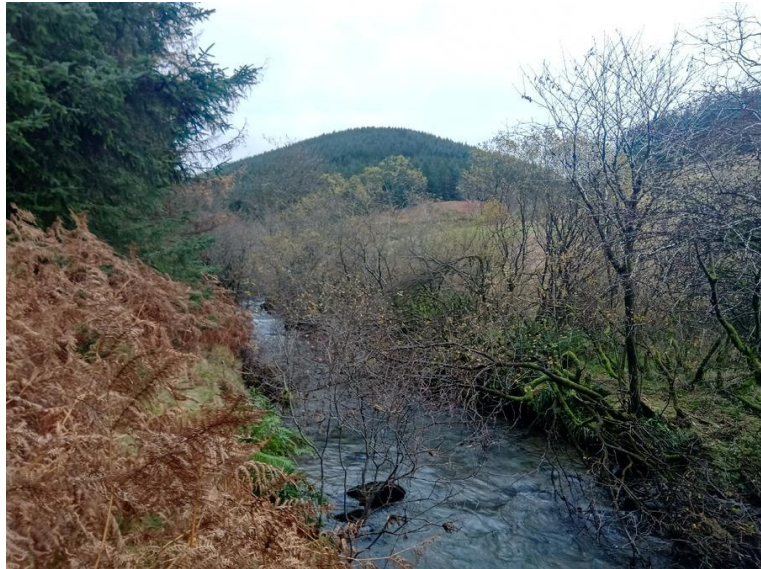
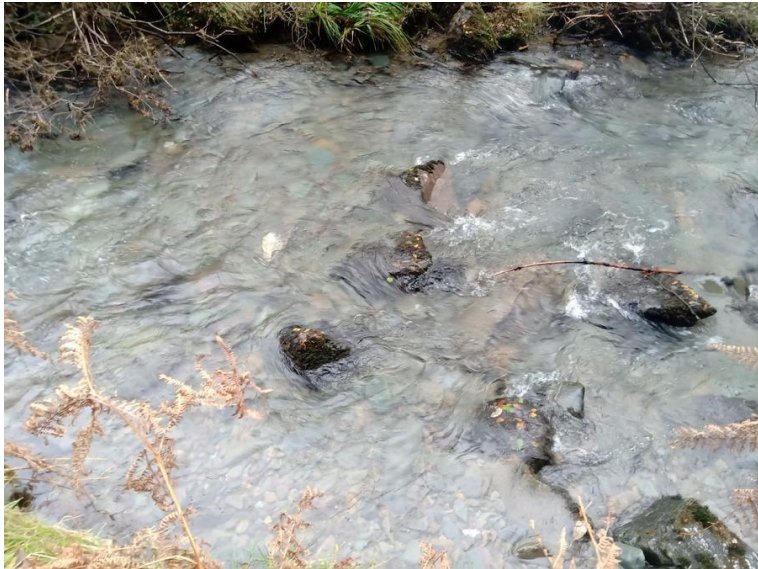
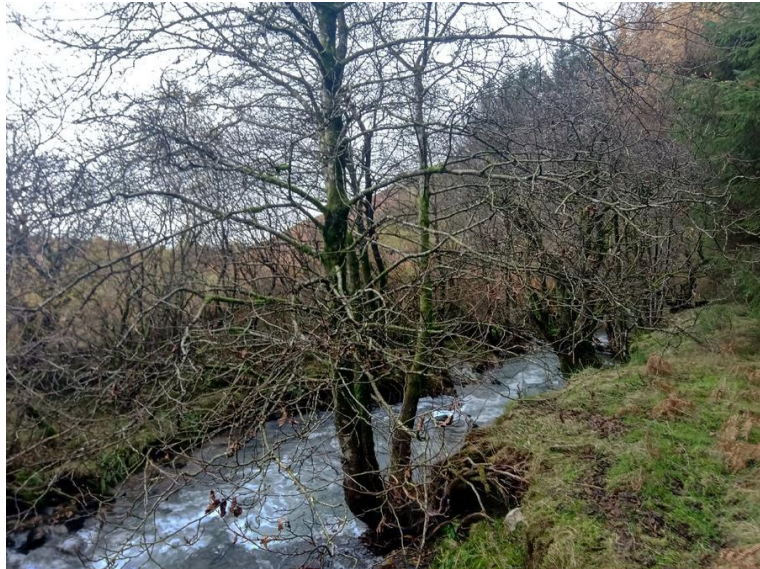
Table 10.4: Watercourse crossing WC51

Crossing Photographs		
Upstream	Across	Downstream

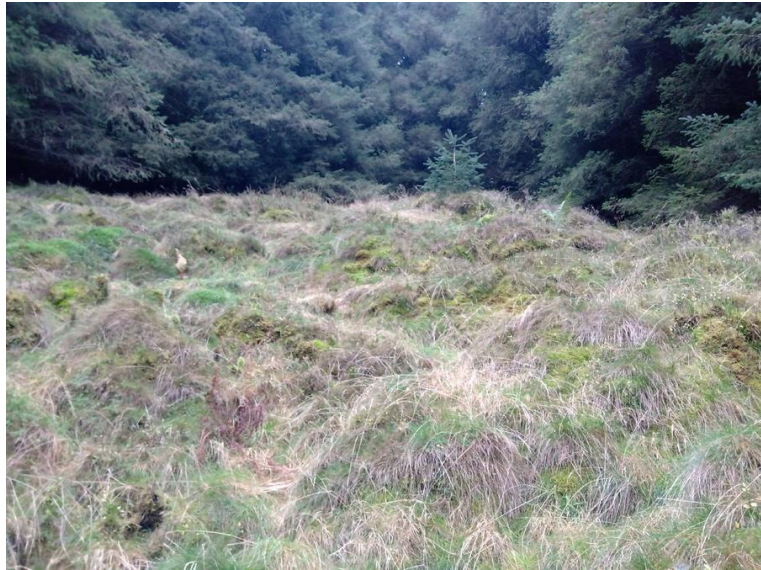
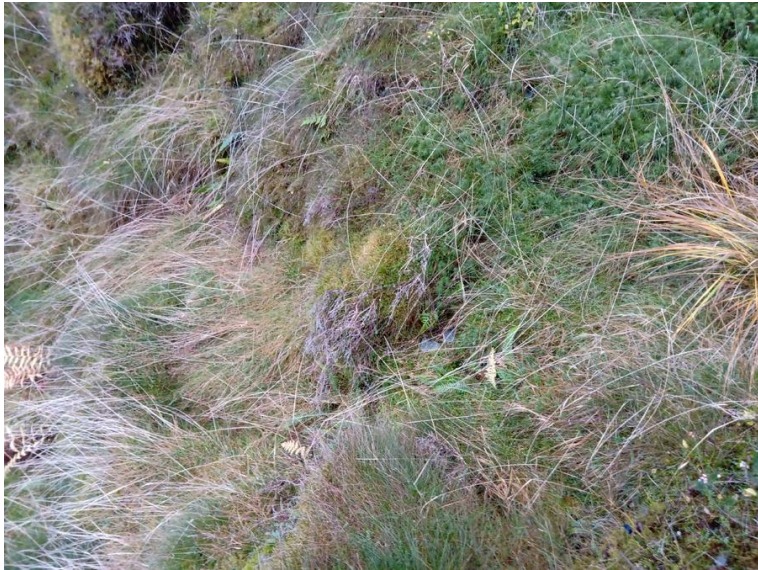
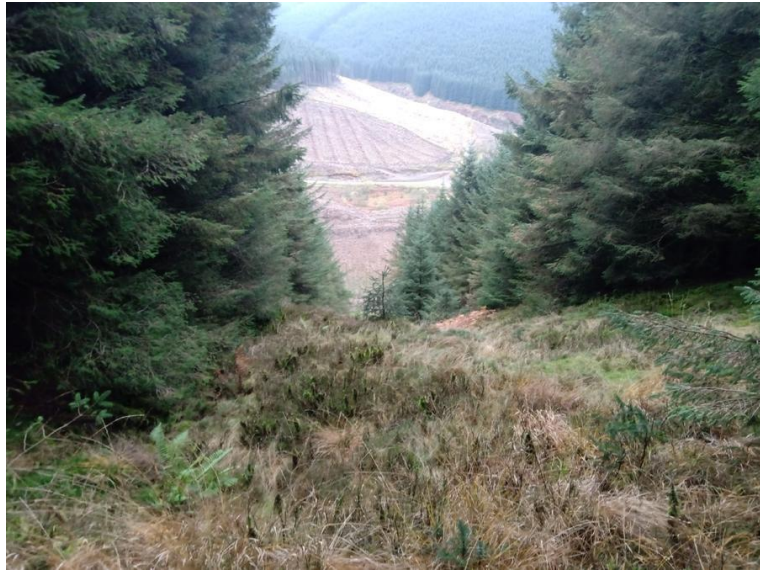
Table 10.5: Watercourse crossing WC52

<p>© Crown Copyright 2023. All rights reserved. Ordnance Survey Licence</p>	<p><b>Existing Crossing:</b> No</p> <p><b>Channel Type:</b> Poorly defined</p> <p><b>Gradient:</b> Steep</p> <p><b>Valley form:</b> Vee</p> <p><b>Bank condition:</b> Stable</p> <p><b>Bed material:</b> Soil, Vegetation</p> <p><b>Riparian corridor:</b> Commercial Forestry</p> <p><b>Flow condition:</b> Dry</p> <p><b>Water width (m):</b> -</p> <p><b>Water depth (m):</b> -</p> <p><b>Bankfull width (m):</b> 0.90</p> <p><b>Bankfull height (m):</b> 0.30</p> <p><b>Banktop height (m):</b> -</p> <p><b>Flooded Bankfull width (m):</b> Not apparent</p> <p><b>Flooded Bankfull height (m):</b> Not apparent</p> <p><b>Note:</b> Grid reference for crossing based on mapped watercourse in woods. Undefined channel with no obvious flow. Wide sloped area leading into main channel. Channel becomes more defined at NT 13914 00624. Still grassy with no water running. Watercourse is not shown on OS 1:50,000 scale digital mapping. It is only shown on the OS 1:25,000 and therefore no authorisation under the CAR is required. GBR will apply.</p> <p><b>CAR Auth Level:</b> GBR</p> <p><b>Proposed Crossing Type:</b> Circular pipe</p>

Crossing Photographs		
Upstream	Across	Downstream

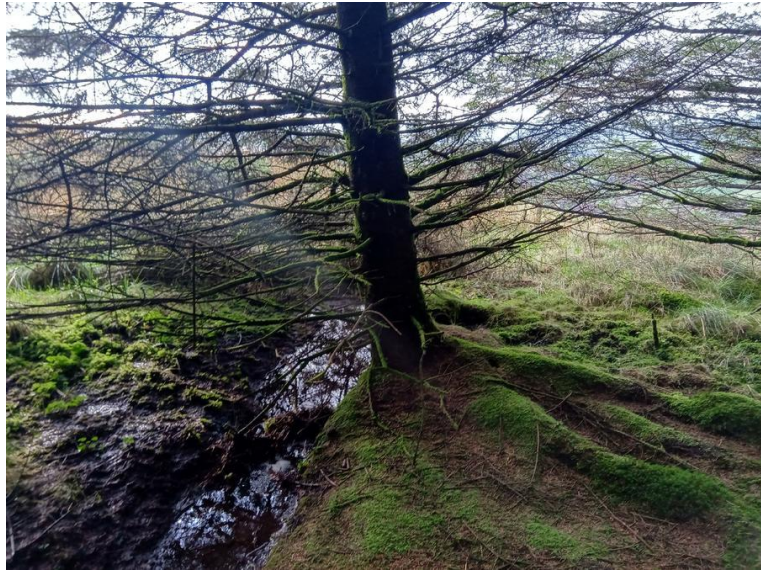
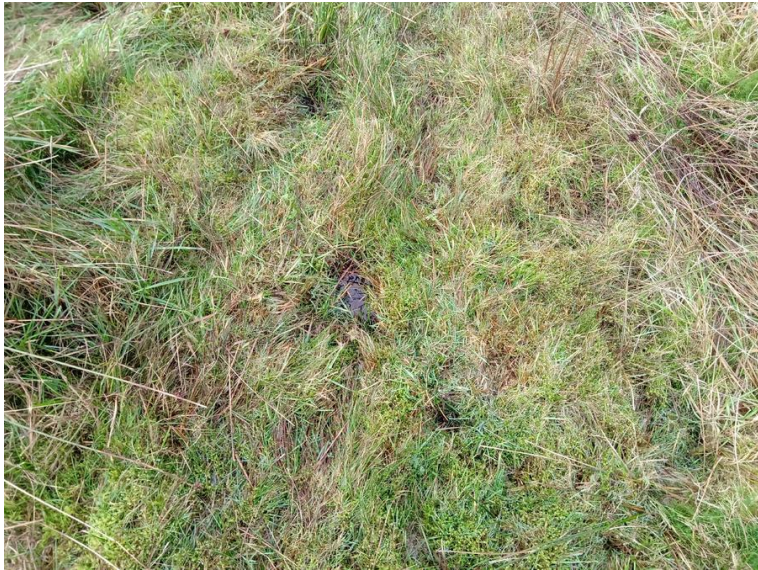
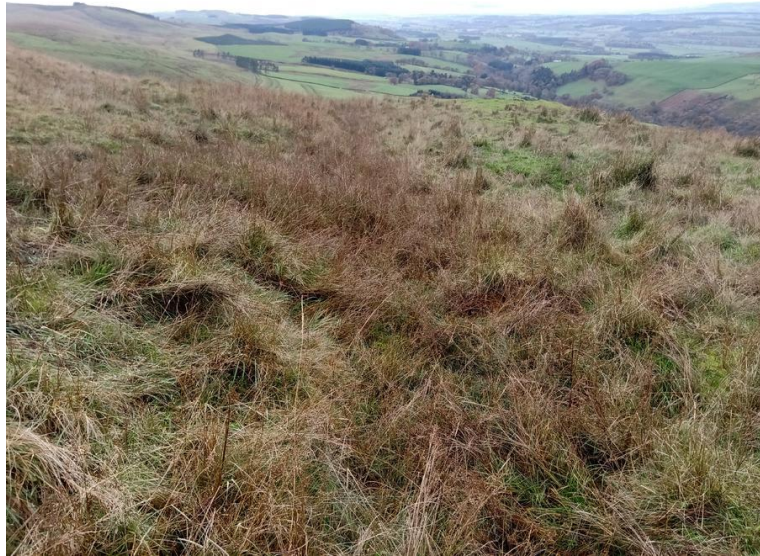
**Table 10.6 Watercourse crossing WC53**

<p>© Crown Copyright 2023. All rights reserved. Ordnance Survey Licence</p>	<p><b>Existing Crossing:</b> No</p> <p><b>Channel Type:</b> Poorly defined</p> <p><b>Gradient:</b> Gentle</p> <p><b>Valley form:</b> No obvious valley sides</p> <p><b>Bank condition:</b> Stable</p> <p><b>Bed material:</b> Vegetation, Soil, Peat</p> <p><b>Riparian corridor:</b> Agricultural Grazing, Commercial Forestry</p> <p><b>Flow condition:</b> Very slow</p> <p><b>Water width (m):</b> 0.40-0.90, non-defined as marshy.</p> <p><b>Water depth (m):</b> 0.05-0.10</p> <p><b>Bankfull width (m):</b> Marshy area about 6m wide.</p> <p><b>Bankfull height (m):</b> 0.01</p> <p><b>Banktop height (m):</b> -</p> <p><b>Flooded Bankfull width (m):</b> - Not apparent.</p> <p><b>Flooded Bankfull height (m):</b> - Not apparent.</p> <p><b>Note:</b> Grid reference for crossing based on mapped watercourse in woods. Undefined channel with no obvious flow. <b>Watercourse is not shown on OS 1:50,000 scale digital mapping. It is only shown on the OS 1:25,000 and therefore no authorisation under the CAR is required. GBR will apply.</b></p> <p><b>CAR Auth Level:</b> GBR</p> <p><b>Proposed Crossing Type:</b> Circular pipe</p>

Crossing Photographs		
Upstream	Across	Downstream

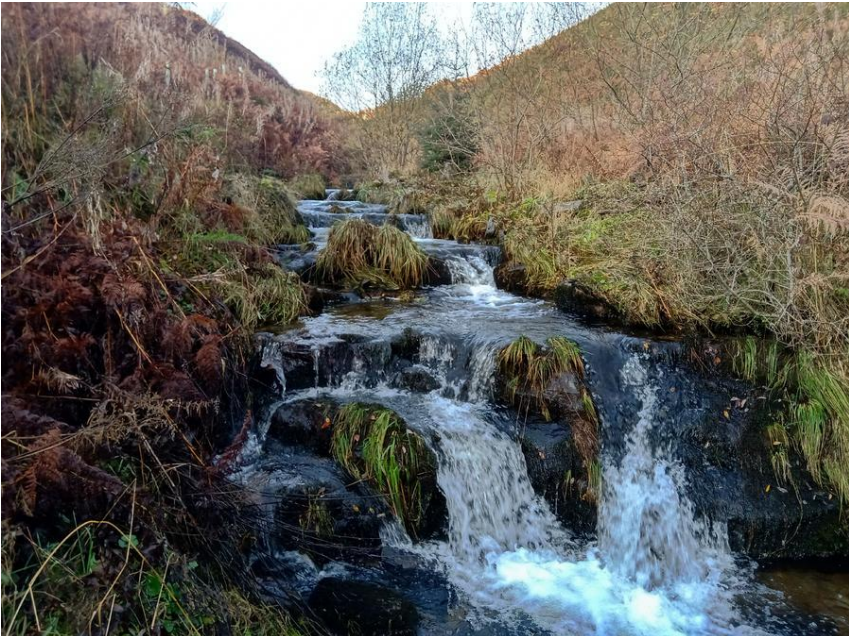
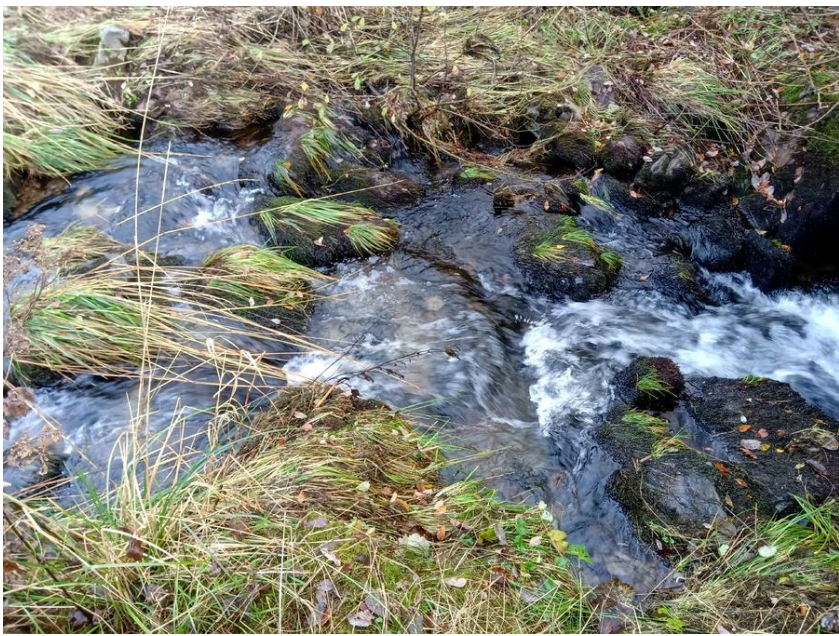
**Table 10.7 Watercourse crossing WC54**

<p>© Crown Copyright 2023. All rights reserved. Ordnance Survey Licence</p>	<p><b>Existing Crossing:</b> Yes</p> <p><b>Crossing Type (existing):</b> Circular Culvert</p> <p><b>Crossing Material (existing):</b> Plastic</p> <p><b>Crossing Condition (existing):</b> Good</p> <p><b>Channel Type:</b> Meandering</p> <p><b>Gradient:</b> Moderate</p> <p><b>Valley form:</b> Vee</p> <p><b>Bank condition:</b> Stable</p> <p><b>Bed material:</b> Rounded pebbles, sand/silt, Coarse gravel, Boulders</p> <p><b>Riparian corridor:</b> Commercial Forestry</p> <p><b>Flow condition:</b> Fast</p> <p><b>Culvert Dimensions (m):</b> 1.40 diameter</p> <p><b>Water width (m):</b> 0.80 - at culvert inlet</p> <p><b>Water depth (m):</b> 0.10 - at culvert inlet</p> <p><b>Bankfull width (m):</b> 2.40</p> <p><b>Bankfull height (m):</b> 0.40</p> <p><b>Flooded Bankfull width (m):</b> 5.00</p> <p><b>Flooded Bankfull height (m):</b> 11.80</p> <p><b>Note:</b> Water width 0.8 m at culvert inlet, but up to 2.4m wide in areas 1-5m upstream due to boulders and varied bank width. Drop at culvert outlet of 1.5m (0.4m water depth there). Opens into a wider pool 0.6m deep and 4.0m wide, then narrows back to channel width of 2m Bankfull width, depth similar upstream. Grass and ferns along riverbank.</p> <p><b>CAR Auth Level:</b> Registration</p> <p><b>Proposed Crossing Type:</b> Existing Circular Culvert (No upgrade necessary)</p>

Crossing Photographs		
Upstream	Across	Downstream

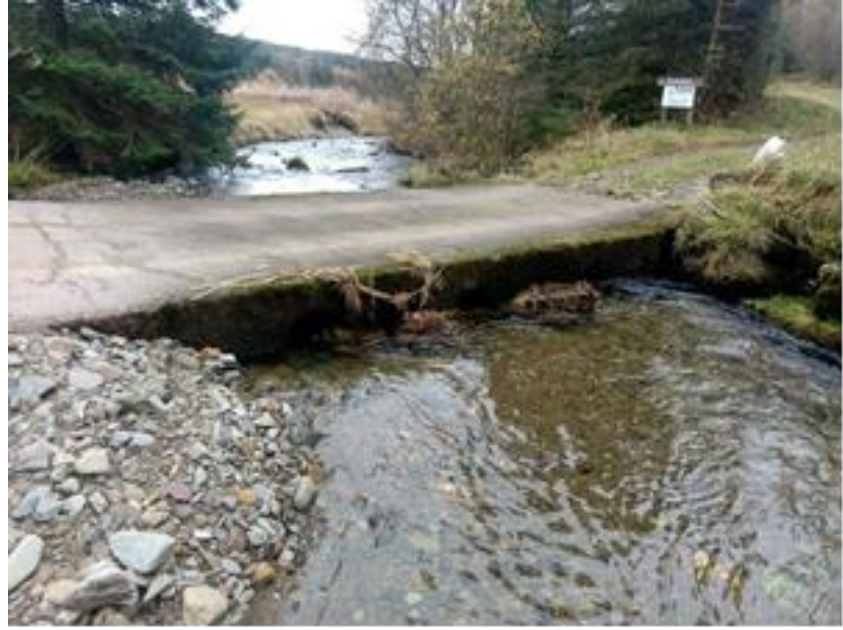
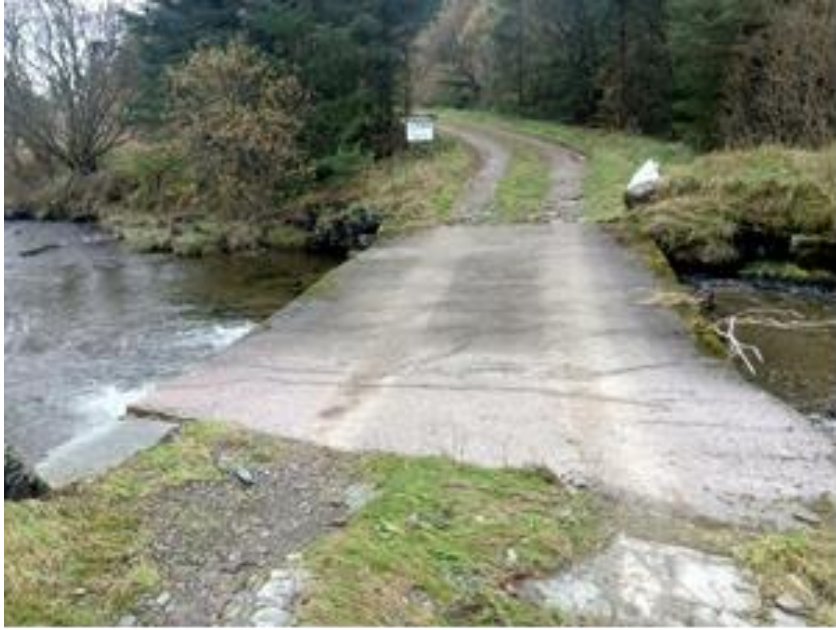
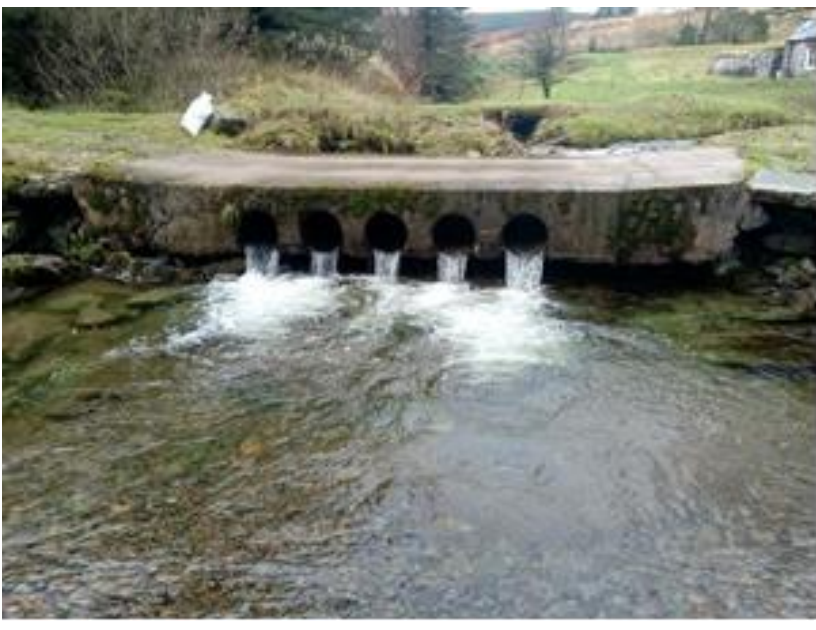
**Table 10.8 Watercourse crossing WC55**

<p>© Crown Copyright 2023. All rights reserved. Ordnance Survey Licence</p>	<p style="text-align: center;"><b>Crossing description</b></p> <p><b>Existing Crossing:</b> Yes  <b>Crossing Type (existing):</b> Bridge (in channel support)  <b>Crossing Material (existing):</b> Concrete  <b>Crossing Condition (existing):</b> Good  <b>Channel Type:</b> Meandering  <b>Gradient:</b> Gentle  <b>Valley form:</b> Shallow vee  <b>Bank condition:</b> Stable  <b>Bed material:</b> Rounded pebbles, Coarse gravel, sand/silt, Boulders  <b>Riparian corridor:</b> Moorland, Agricultural Grazing, Commercial Forestry  <b>Flow condition:</b> Fast</p> <p><b>Culvert Dimensions (m):</b> 5.00m bridge, 5x .0.50m diameter pipes that water flows through  <b>Water width (m):</b> 4.00m on upstream side, 8.00m on downstream side  <b>Water depth (m):</b> 0.30-0.50  <b>Bankfull width (m):</b> 4.00  <b>Bankfull height (m):</b> 0.90  <b>Flooded Bankfull width (m):</b> 8.00  <b>Flooded Bankfull height (m):</b> 1.20 (measured on downstream side of bridge due to drop)</p> <p><b>Note:</b> A tributary enters main channel about 3m upstream of bridge.</p> <p><b>CAR Auth Level:</b> Simple License  <b>Proposed Crossing Type:</b> Existing Bridge (Repair)</p>

<b>Crossing Photographs</b>		
<p style="text-align: center;"><b>Upstream</b></p>

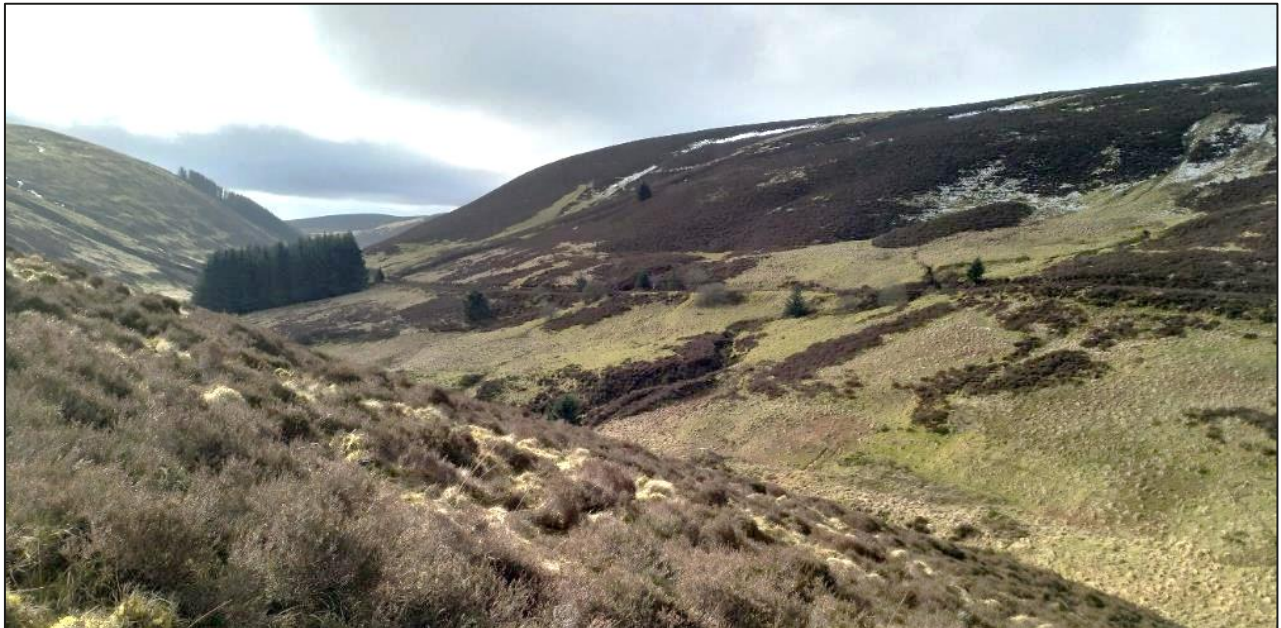
Figure 3.4: Photo: Typical terrain of proposed development.

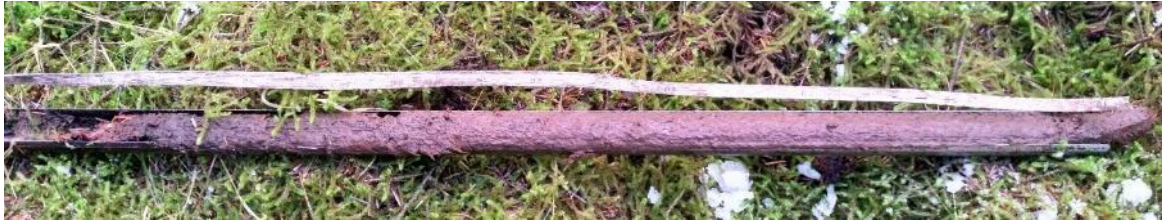
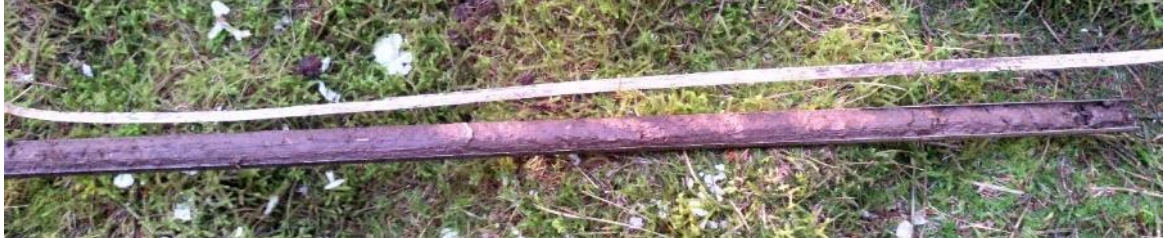
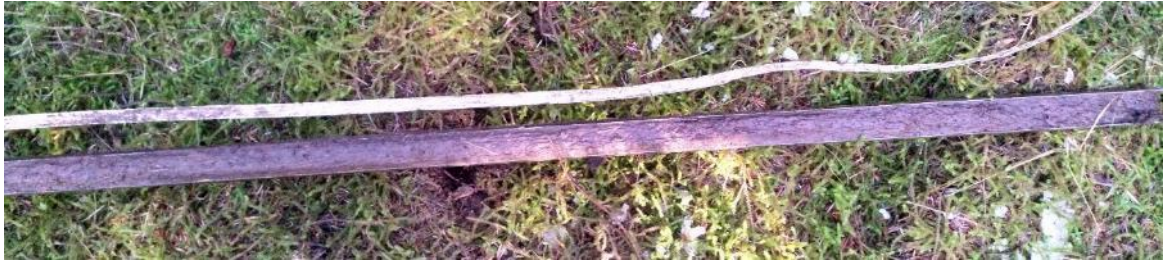
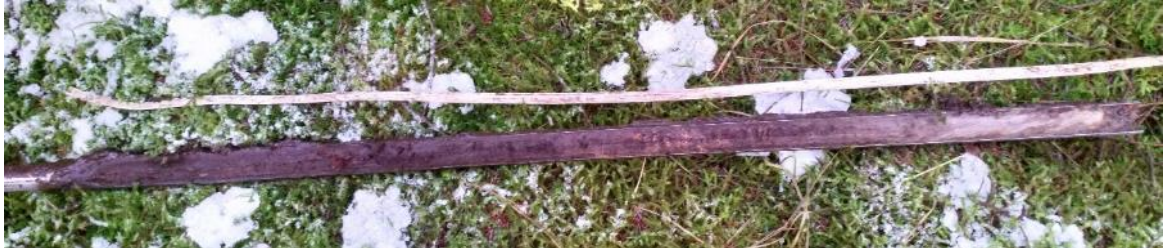
Table 5.12: Peat Core Photos

Peat Core Photos	
<b>PC01</b>

<p>0.00-1.00m</p>

<p>1.00-2.00m</p>

<p>2.00-3.00m</p>

<p>3.00-3.70m</p>
<b>PC02</b>

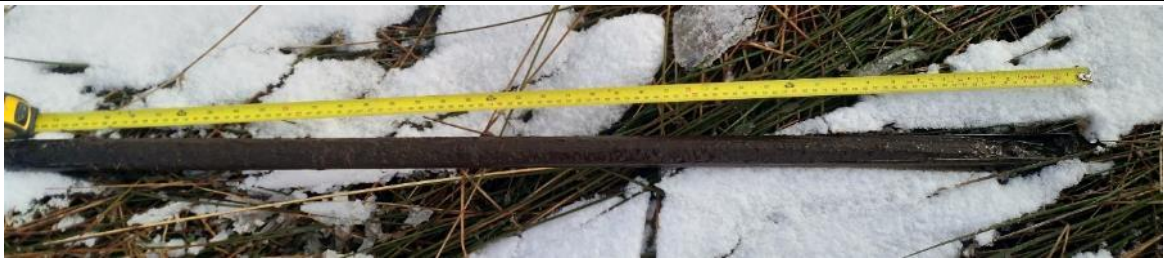
<p>0.00-1.00m</p>

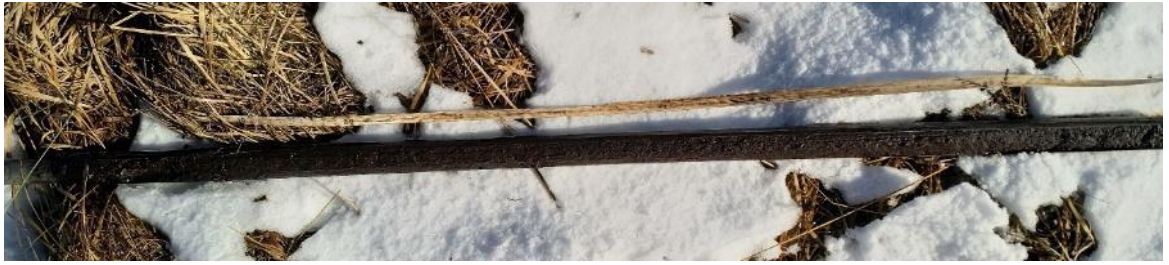
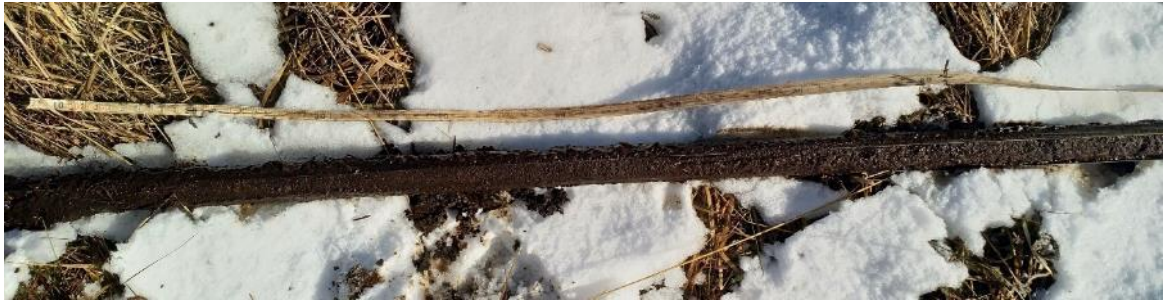
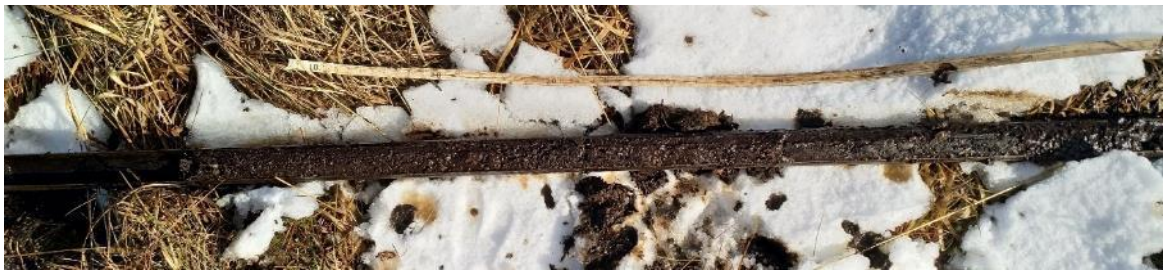
**PC03**

**0.00-1.00m**

**1.00-2.00m**

**2.00-2.80m**

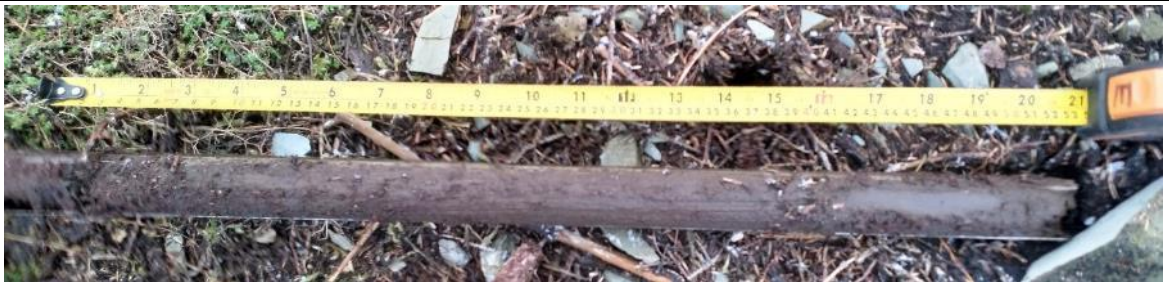
**PC04**

**0.00-0.50m**

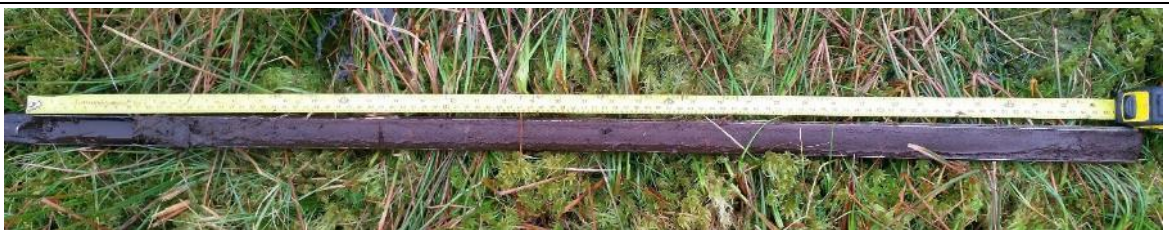
**PC05**

**0.00-1.00m**

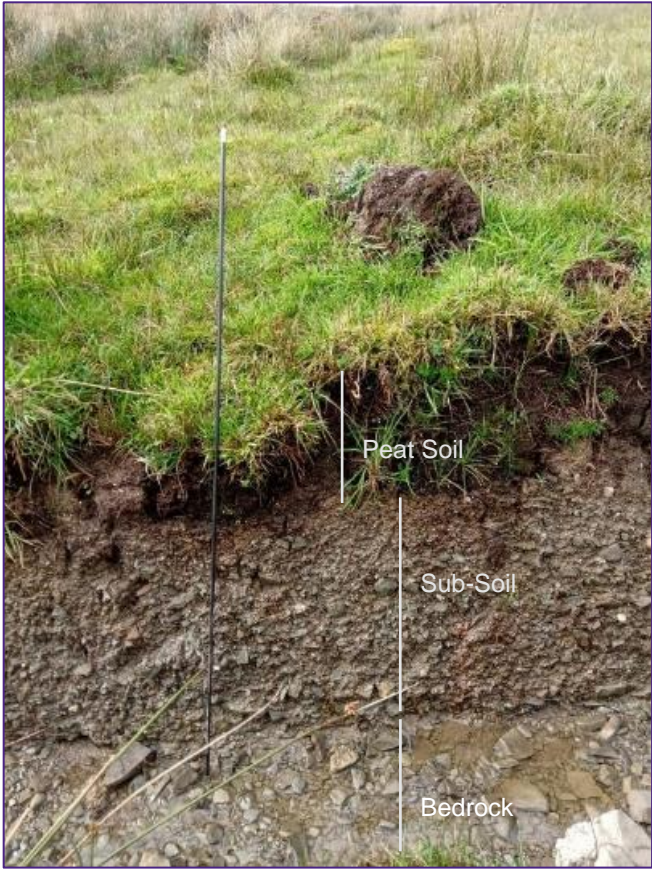
Figure 5.3: Typical shallow soil profile for Scoop Hill Wind Farm

In Figure 5.3; a thin peaty topsoil (0.1-0.3m) is overlying a mixed granular glacial sub-soil. This sequence was found to be very typical across the proposed development and revealed in artificial drainage ditches and cuttings. Such evidence has been included in the overall assessment of the peatland coverage and subsequent detailed survey design and assessment.

Where peat accumulations are absent, peaty topsoil is dominant. Figure 5.3 shows the typical soil profile of the open and upland moorland:

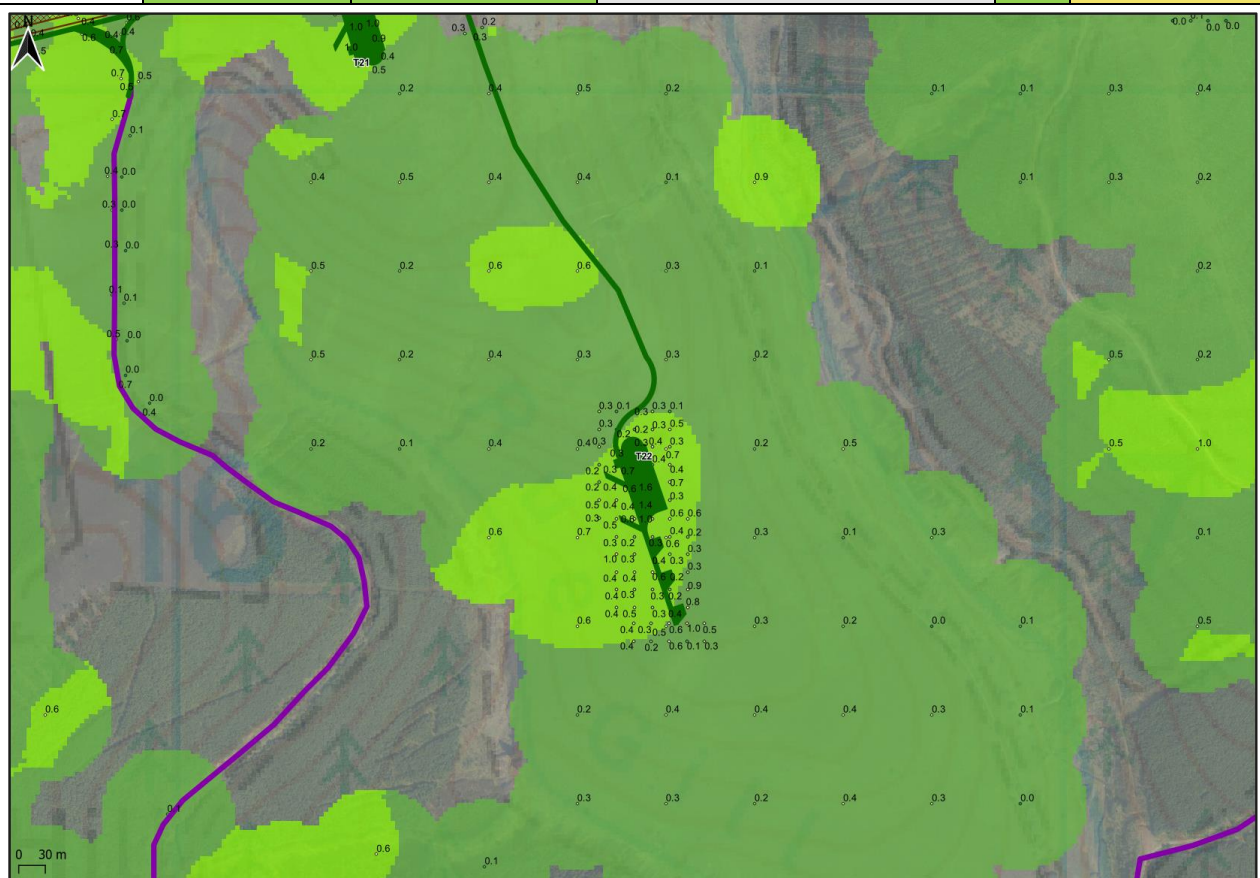
Recommendations	Residual Risk
<ul style="list-style-type: none"> <li>Reported Risk Category <b>Low</b></li> <li>Mean Peat Depth at Proposed Infrastructure - 0.45m based on detailed probing. Low angle terrain coincident with deeper peat. The controlling and steeper sloping terrain to the east recorded absent peat. With gentler slopes to the west holding peat to a depth of 0.7m.</li> <li>Mean Peat Depth Surrounding Area – Absent thin soils / not peatland, mean soil depth 0.25m across the wider ridge system.</li> <li>Terrain slope is low angle along the axis of the ridge line but increases to the east and west off the ridge line.</li> <li>Utilise and maintain best working practices while working on a peatland site.</li> <li>Ensure hydrological regime is maintained throughout construction and life of the foundation.</li> <li>Surrounding terrain is not peatland and contributory factors (signs of previous instability, hydrology, groundwater, and infiltration) at the proposed turbine location indicated a low peat slide risk.</li> <li>The location is a significant distance from the nearest watercourse.. Peat survey information shows widespread shallow peat or absent peat in the surrounding terrain.</li> </ul>	<h2>Negligible</h2>

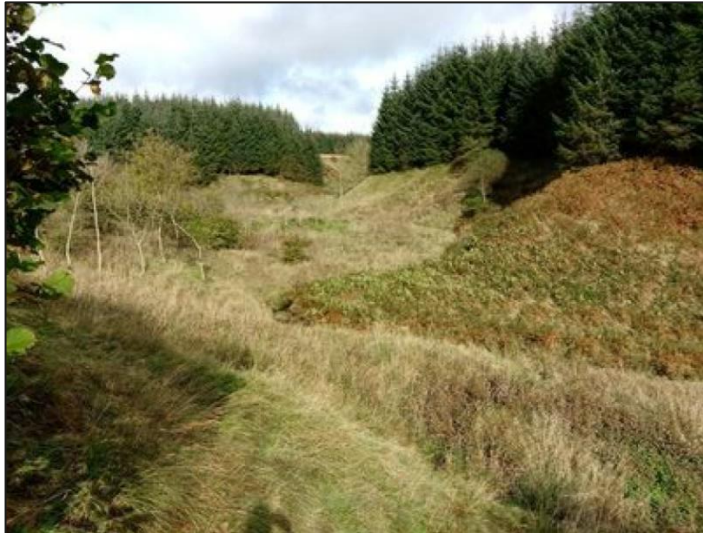
Figure 9.1: Glaciofluvial valley system with steep escarpments, devoid of peat; west of Turbine 57

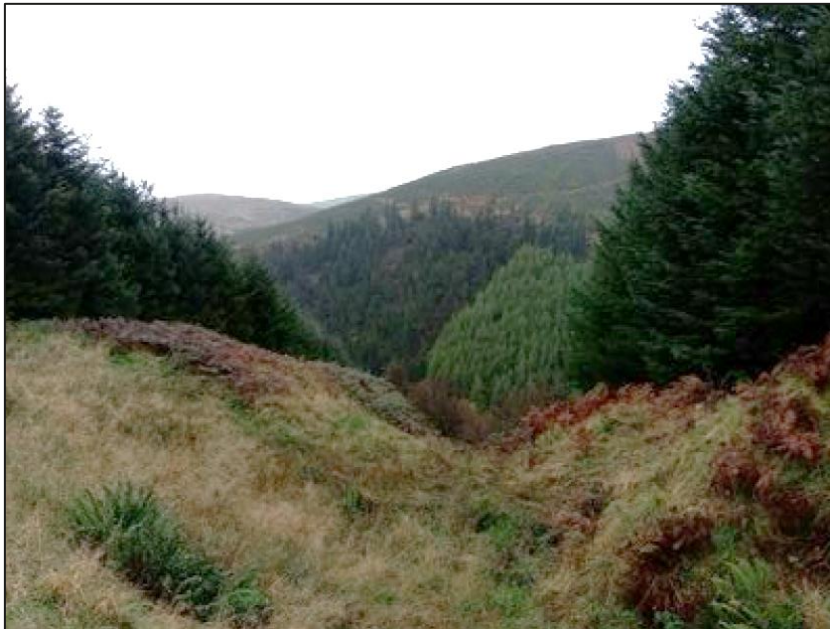
Figure 9.2: Example of steep terrain of the Dryfe Water Valley

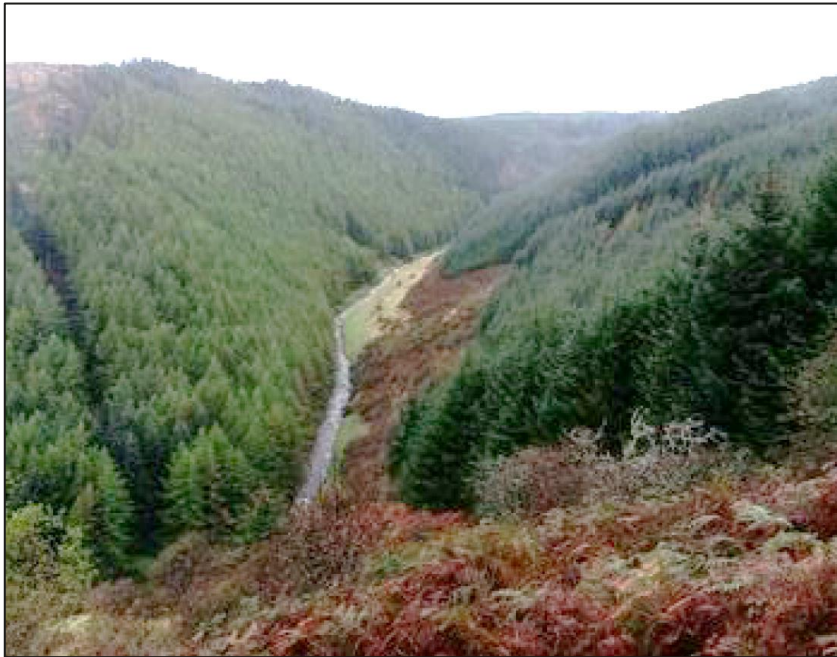
Figure 9.3: Additional view showing steepened valley sides of Dryfe Water Valley

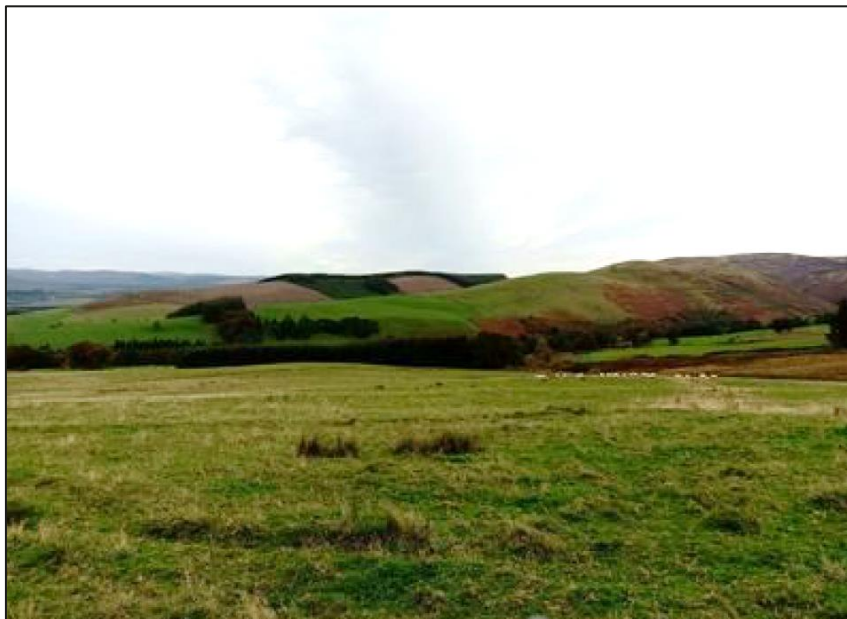
Figure 9.4: Example terrain type: grazing pasture (thin mineral soil and no peat): Ridge in distance location of Turbines 63, 64, 66 & 67 with similar superficial soils

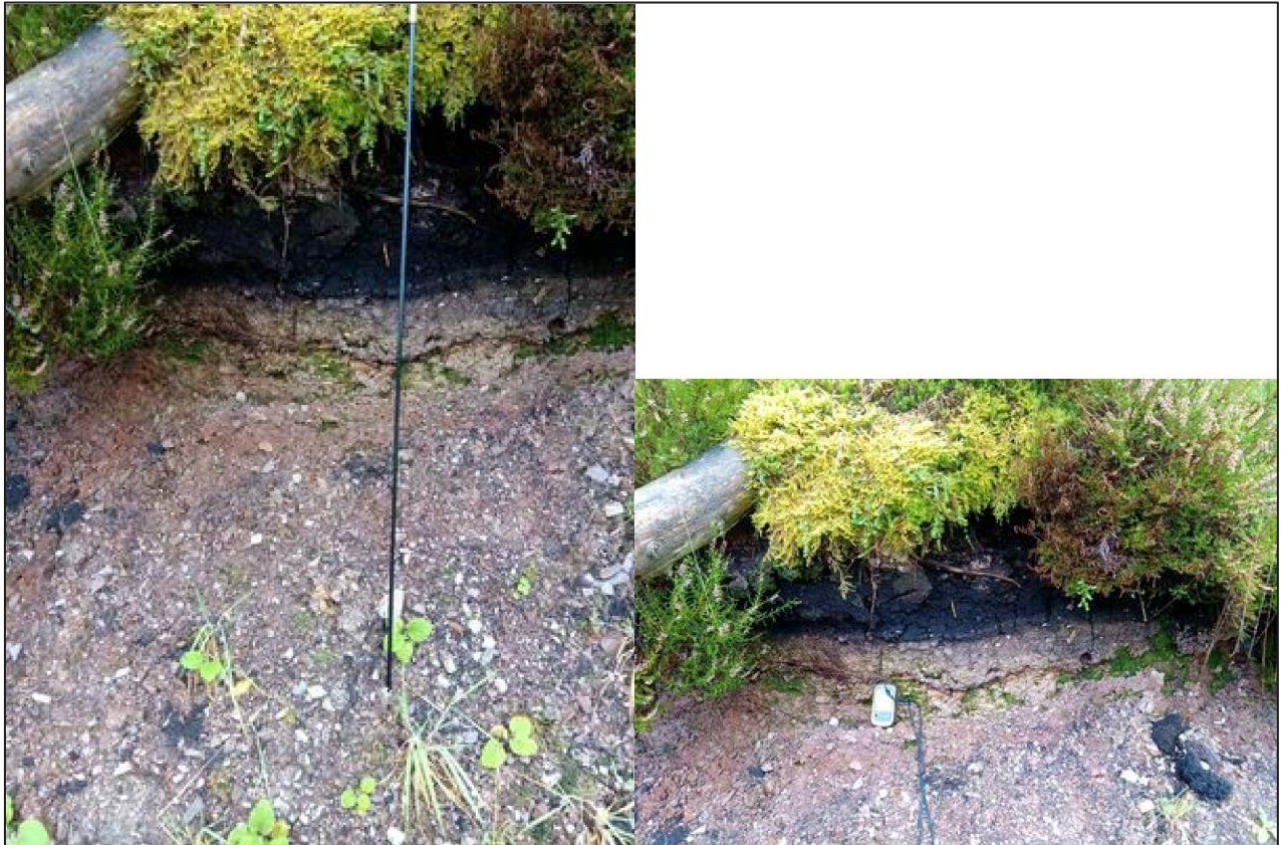
Figure 9.5: Turbine T49 & T50 soil profile exposing thin peat soil layer 0.1 – 0.4m thickness

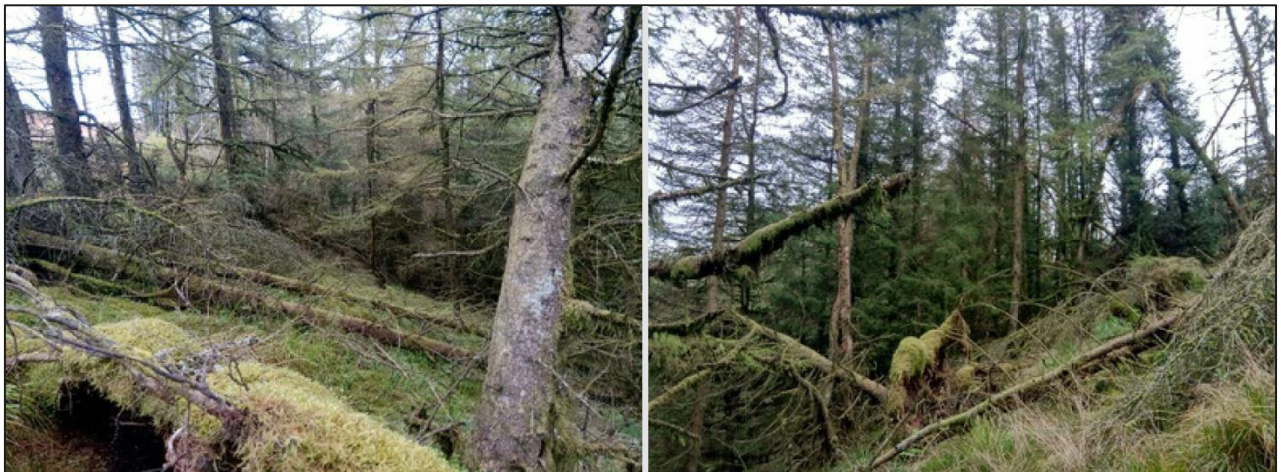
Figure 9.6: Infrastructure looking south towards T49 - inaccessible for probing due to wind blow

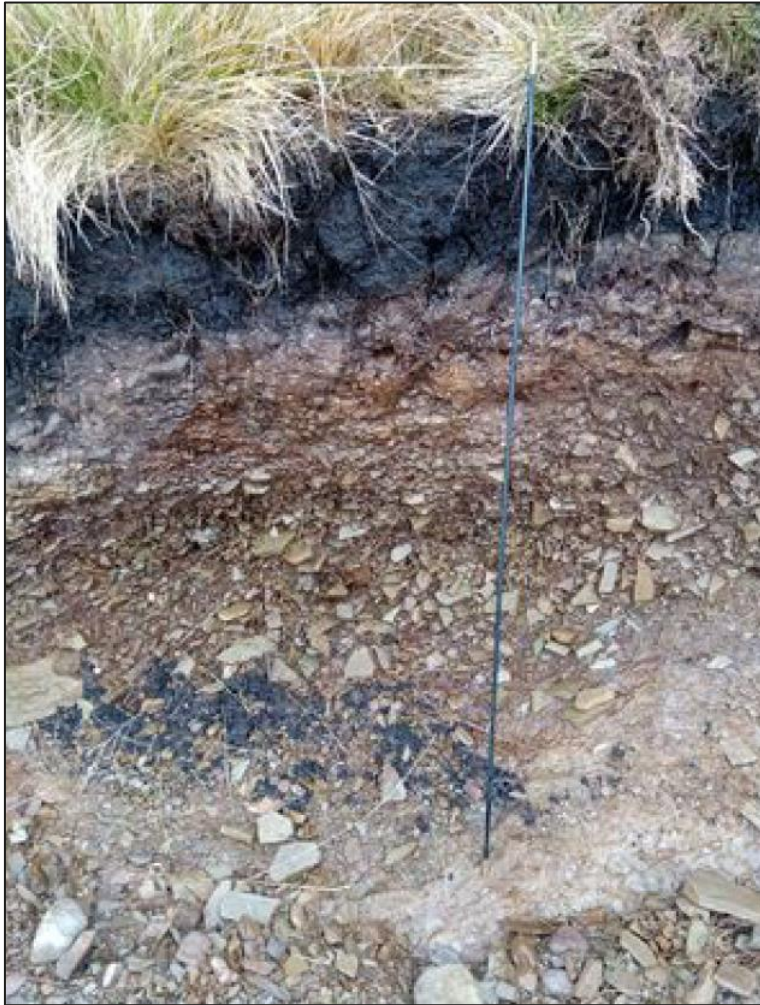
Figure 9.7: Example soil profile at Turbine T32 showing thin peat layer (1m probe for scale)
