**Section 10**  
**HYDROLOGY, GEOLOGY AND HYDROGEOLOGY**

## Section 10: HYDROLOGY, GEOLOGY AND HYDROGEOLOGY

10.1.1 Natural Power Consultants Ltd (Natural Power) have undertaken a revised assessment of the potential impacts on geological, hydrological and hydrogeological receptors as a result of the construction and operation of the proposed Scoop Hill Community Wind Farm, located in Dumfries & Galloway, on behalf of Community Windpower Limited (CWL).

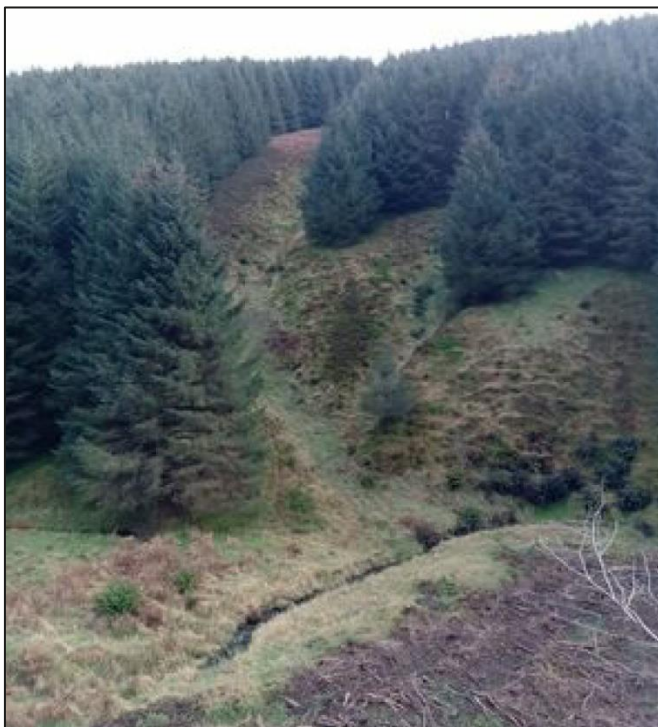
**Figure 9.8:** Steep forested terrain south from T25 no peat recorded by 100m grid probing for this terrain type

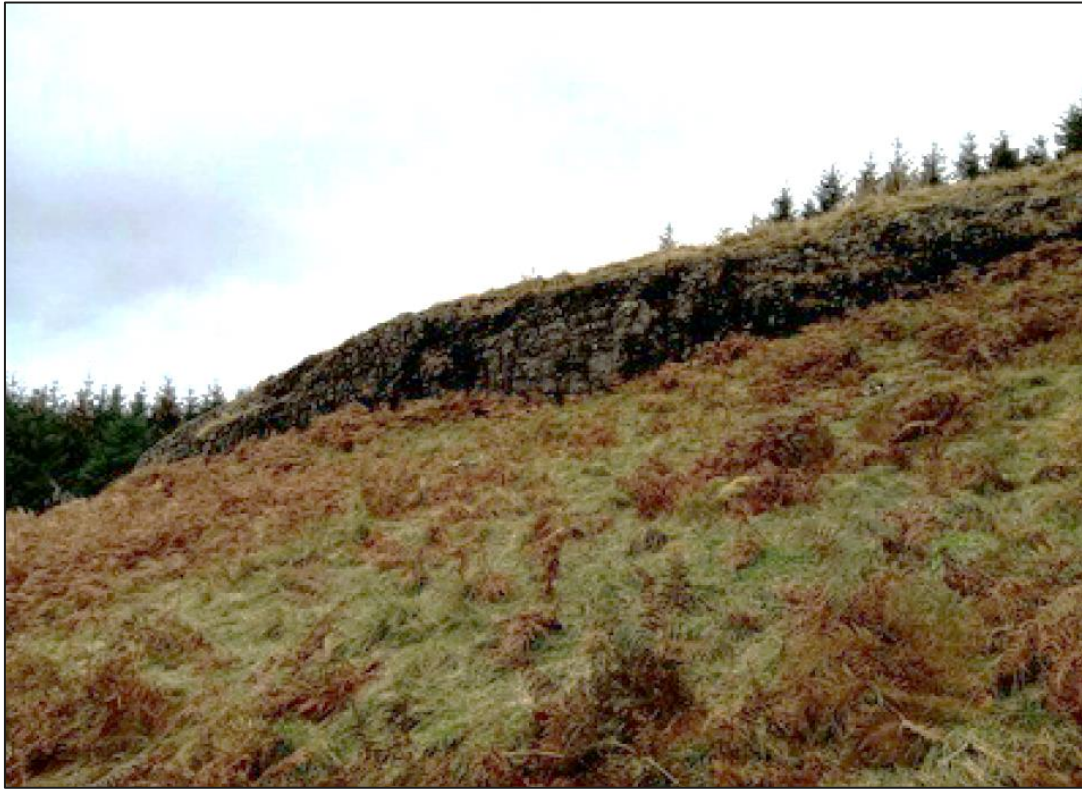
**Figure 9.9:** Further type location steep valley sides (no peat recorded) vicinity of Turbine T23

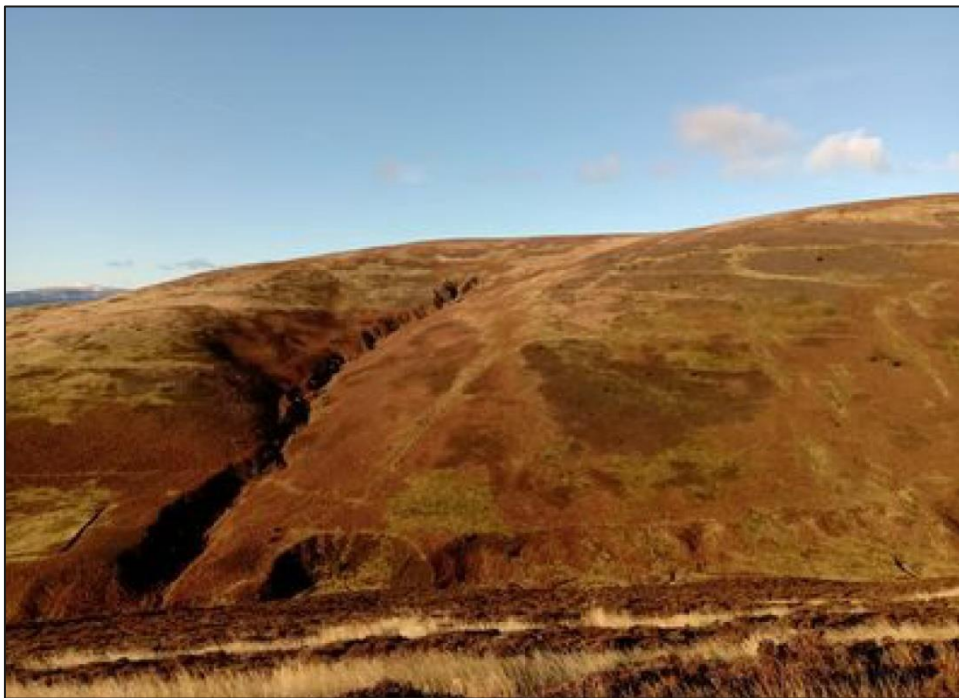
Figure 9.10: Example terrain: bedrock exposure and no peat on approach to T30

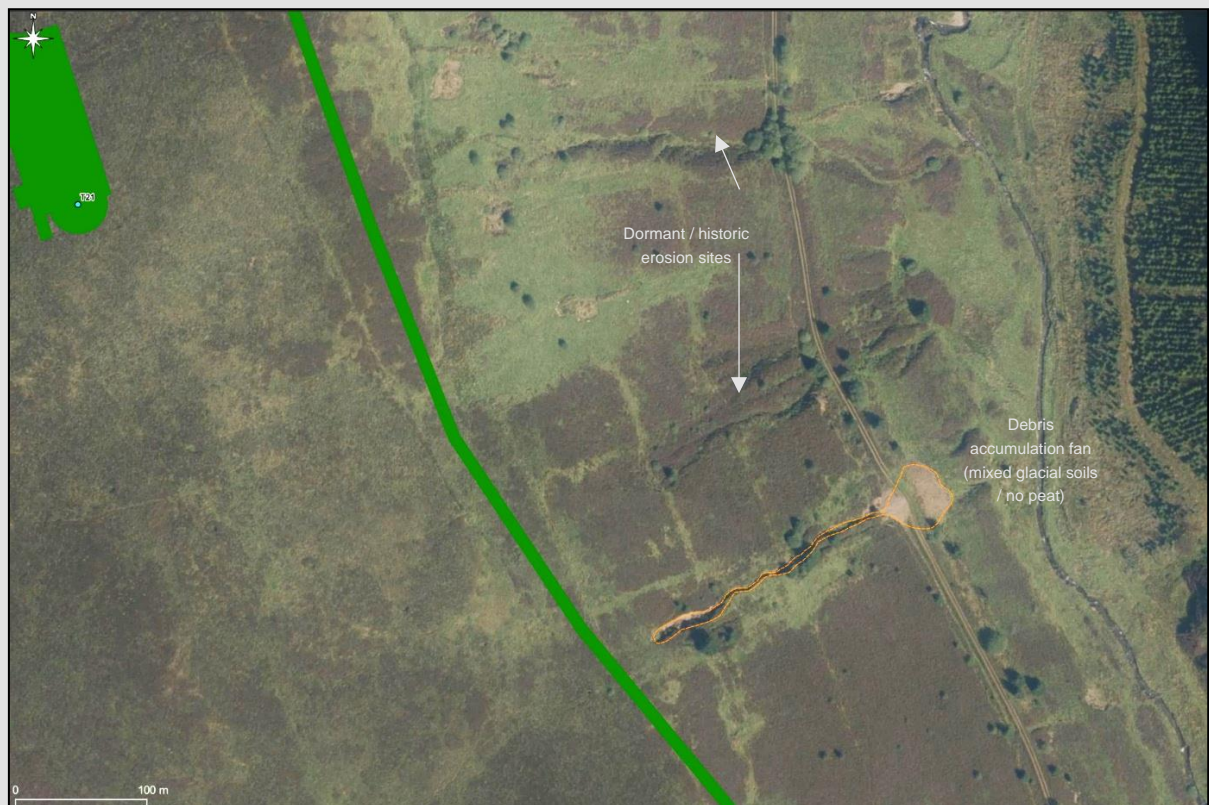
Figure: Extract from Geomorphological Mapping Showing previous mass movement (superficial soils) type location south-east of T21.

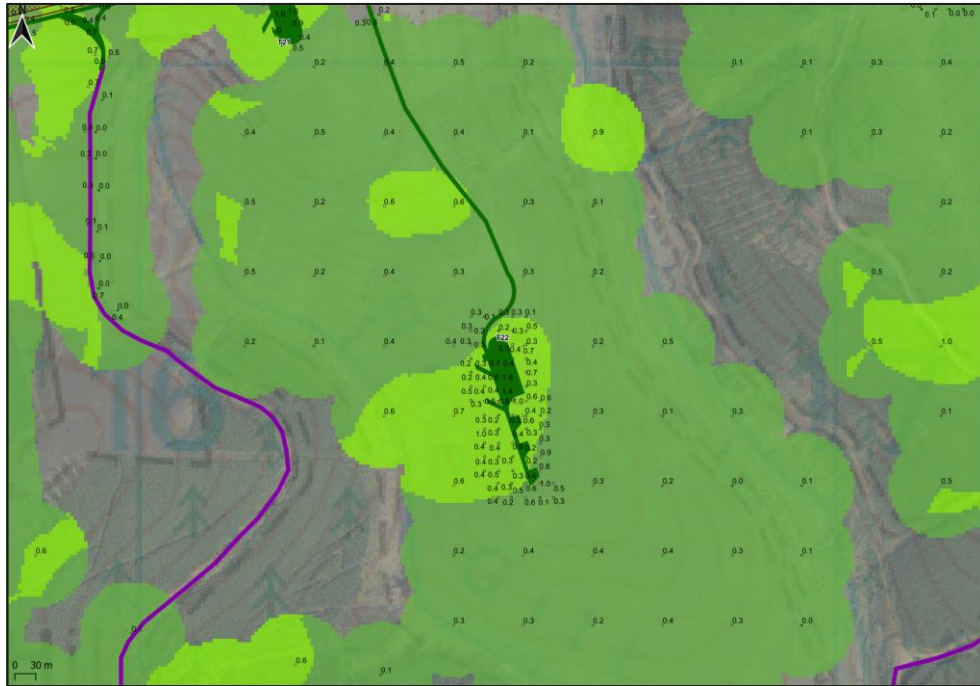
- Reported Risk Category **Low**
- Mean Peat Depth at Proposed Infrastructure - 0.45m based on 100m grid. Low angle terrain where deeper peat expected. The controlling and steeper sloping terrain to the east recorded absent peat. With gentler slopes to the west up to 0.7m.
- Mean Peat Depth Surrounding Area – Absent thin soils / not peatland, mean soil depth 0.25m across the wider ridge system.
- Terrain slope is low angle along the axis of the ridge line but increases to the east and west off the ridge line.

**T22 - Peat Depth and Elevation Contours (2m interval) with 3D terrain view for wider context**

Detailed peat probing has now been undertaken at this location, please refer to Tables 7.1 and 7.2 of this report for the detailed assessment.

The location is a significant distance from the nearest watercourse. The current risk assignment and mitigation measures stated are deemed valid for the planning phase. Peat survey information shows widespread shallow peat or absent peat in the surrounding terrain and intrusive site investigation at the pre-construction stage is the logical time to undertake further detailed surveys.

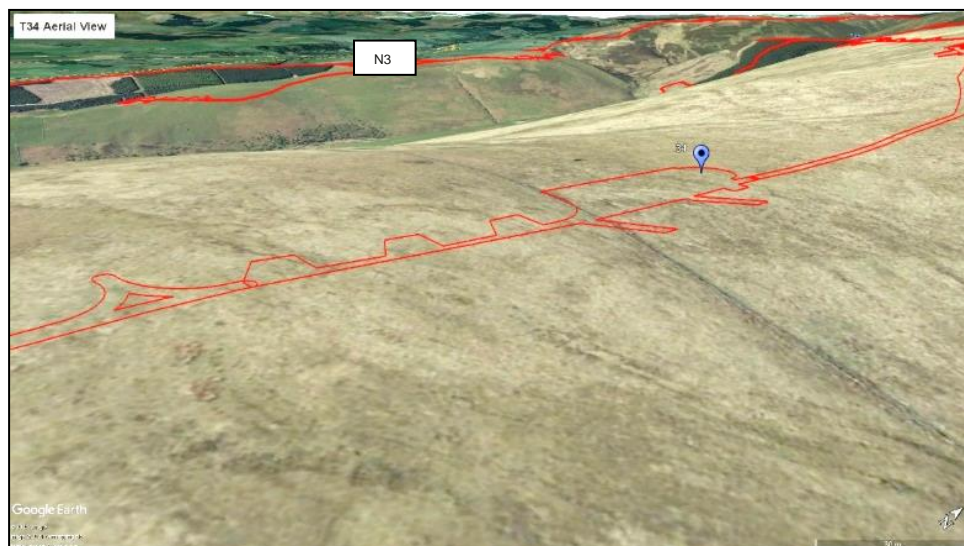
- Risk Category - **Low**
- Mean Peat Depth at Proposed Infrastructure - 0.4m. An isolated probe depth of 0.6 is recorded on the north side of the turbine location on level ground and then > 200m west and east of the turbine location. Terrain analysis and the grid probing survey data indicated a shallow / absent peat depth or thin mineral soil layer.
- Mean Peat Depth Surrounding Area – Peat is majority absent with thin soils (mean – 0.3m) widespread across the down-slope system.
- Terrain: 6°
- **T34 - Peat Depth and Elevation Contours (2m interval) with 3D terrain view for wider context**

At the proposed infrastructure location and across the surrounding terrain (down-slope) there is no deep peat on sloping ground and contributory factors at proposed turbine locations (signs of previous instability, hydrology, groundwater, and infiltration) indicated a low-risk location. Further survey information at this location will not in the view of Natural Power increase the precision of the risk assessment.

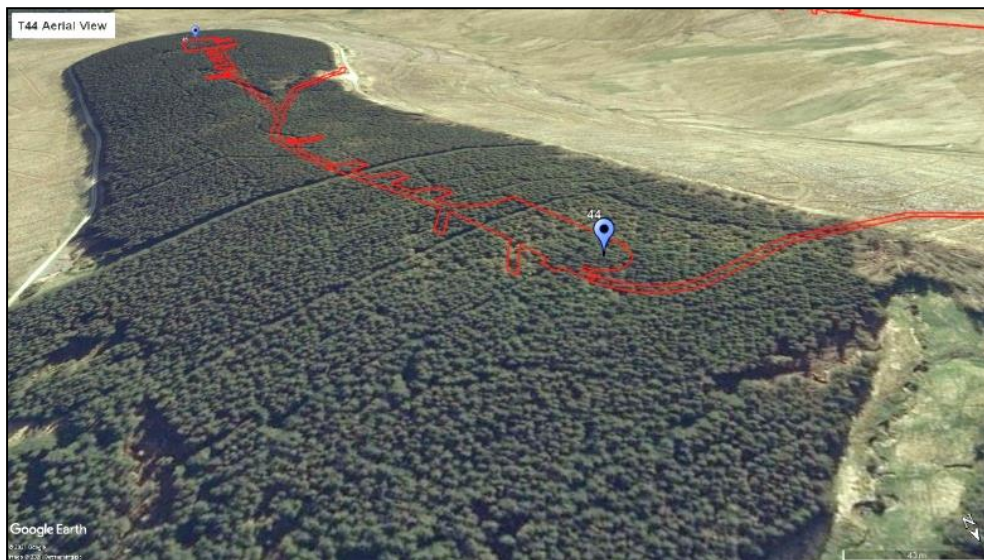
- Risk Category - **Low**
- Mean Peat Depth at Proposed Infrastructure - 0.25m. Marginally deeper probe depth (0.6m) recorded ~75m west of the turbine location although on the opposing side of the ridge. Depths of 0.6m were further recorded south across the access infrastructure.
- Mean Peat Depth Surrounding Area – Peat is thin and generally <0.5m across the controlling downslope system to the east to which the proposed infrastructure occupies.
- Terrain slope angle of 11°.

**T44 - Peat Depth and Elevation Contours (2m interval) with 3D terrain view for wider context**

Based on this information the location of T44 was not initially prioritised for detailed assessment as it does not represent a location from where there is a significant impact potential from peat slide. Although during early phases of the survey obscured by commercial forestry plantation which negated practical access for detailed peat probing, the generally shallow peat depths across this area warrants further terrain assessment post-felling. This was completed in the final phase of survey November 2022. Across the surrounding terrain (down-slope from infrastructure) there is no continuous deep peat and contributory factors (Factor of Safety, hydrology, and distance from nearest watercourse) at proposed turbine locations indicate a low-risk location. Detailed probing has confirmed this.

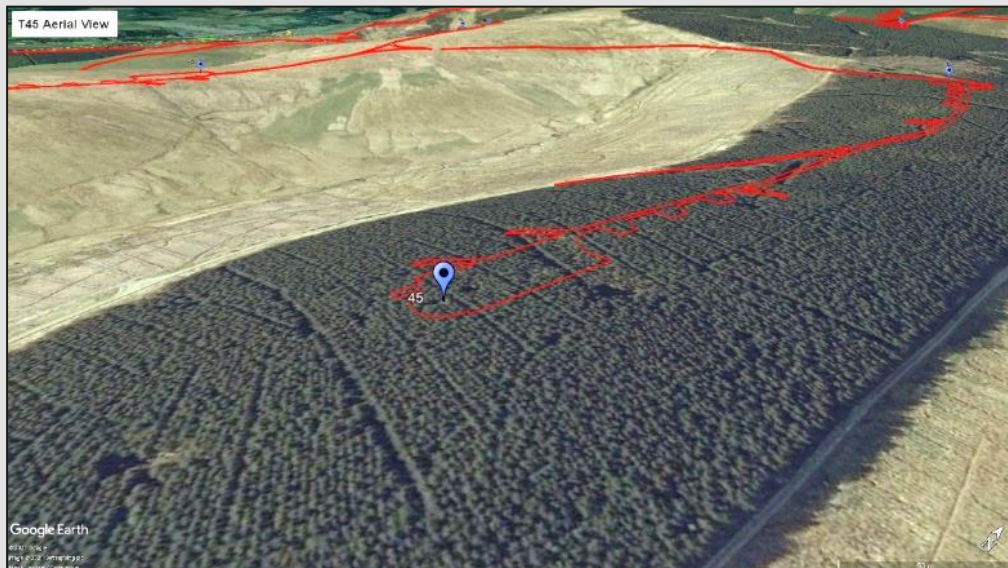
- Risk Category – **Negligible**
- Peat Depth at Proposed Turbine Infrastructure - 0.3m (Thin soils / Absent Peat)
- Mean Peat Depth Surrounding Area – Peat is thin and generally <0.5m across the immediate controlling downslope system to the east and south.
- Terrain 4° slope angle

**T45 - Peat Depth and Elevation Contours (2m interval) with 3D terrain view for wider context & contemporary aerial imagery post felling**

Based on this information the location of T45 was not initially prioritised for detailed peat probing. Marginally deeper peat 0.6m is recorded north across the access infrastructure and west on the opposing side of the ridge system. The proximity of the increased probing depth from the turbine infrastructure and the fact it is on a separate slope system was also considered. Given these factors; this location was not assessed to represent a location where there is a significant impact potential from peat slide. Across the surrounding terrain (down-slope) there is no continuous deep peat and contributory factors (Factor of Safety, hydrology, and distance from nearest watercourse) at proposed turbine locations indicated a negligible risk location. Applying worst-case peat depth factor to the risk model for this location would increase the risk category to low. Thus, additional peat probe survey information was not gathered at the initial stage.

Since conducting the initial peat survey forestry felling has occurred across this section of the site. Detailed probing undertaken November 2022 and additional terrain reconnaissance has confirmed this to be a low-risk location.

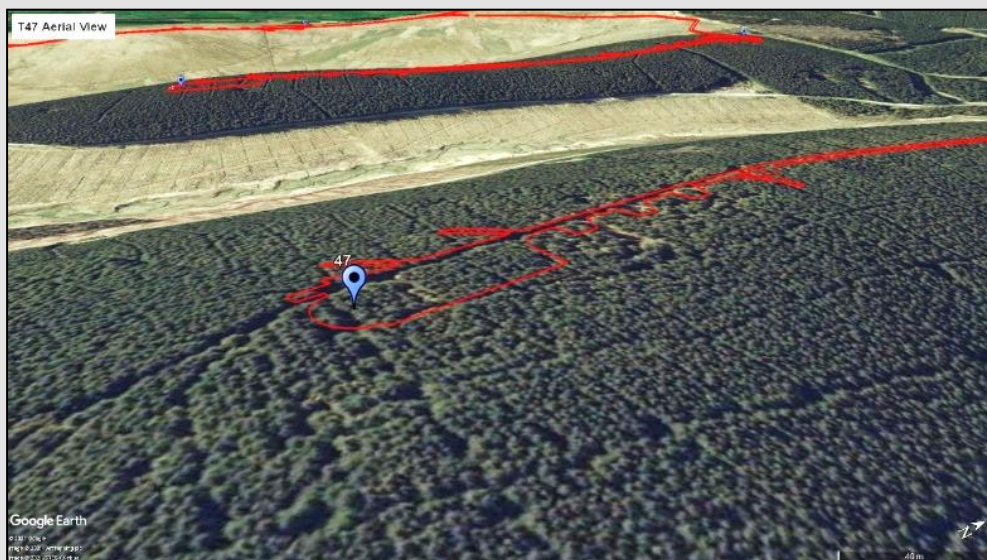
- Risk Category – **Low**
- Mean Peat Depth at Proposed Infrastructure - 0.6m
- Mean Peat Depth Surrounding Area – Peat is thin and generally <0.5m across the immediate controlling downslope system .
- Terrain < 6 degrees terrain slope angle.

**T47 - Probe Depths and Elevation Contours (2m interval) with 3D terrain view for wider context**

Based on this information, the turbine location of T47 was not initially prioritised for detailed probing. As is evident in the image extract above, detailed probing was undertaken along the approaching access infrastructure footprint where deeper peat was initially detected by the 100m grid survey. Detailed probing has confirmed peat of up to 1m depth on level or shallow sloping ground and this was supported by a peat core sample 'PC04' described in the main peat slide risk assessment report (Table 3.15, Ref:1225356). The detailed peat probing was curtailed across the turbine hardstand and foundation location due to the indication for absent peat recorded in the 100m grid probing.

Across the surrounding terrain (down-slope) to the east, south and west; there is no indication of peat accumulation from the 100m grid probing. Final phase survey with detailed probing across this area has confirmed no peat. Contributory factors to peat slide at proposed turbine locations indicate a low-risk location. There was no evidence of previous instability, nor any hydrological indicators recorded. Further survey information at this location will not increase the outcome of the risk assessment in this case. Assuming a worst-case score for peat depth in the risk assessment model does not increase the risk category beyond low due to the absence of other contributory factors (signs of previous instability, Factor of Safety, hydrology), and the significant distance for the nearest watercourse receptor (>380m).

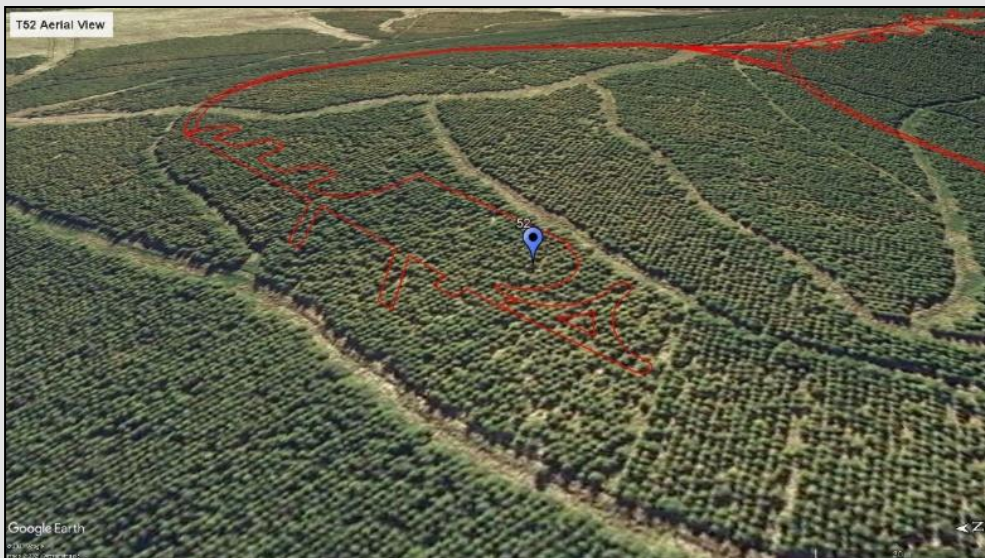
- Risk Category – **Low**
- Mean Peat Depth at Proposed Infrastructure - 0.4m
- Mean Peat Depth Surrounding Area – Peat is thin and generally <0.5m and likely represents a shallow mineral soil.
- Terrain 6° slope angle.

**T52 - Probe Depths and Elevation Contours (2m interval) with 3D terrain view for wider context**

The location of T52 at the time of survey obscured by commercial forestry plantation. However later additional detailed probing was recorded at the turbine foundation location where a maximum probe depth of 0.6m was recorded. The wider 100m grid data surrounding the turbine and within the same terrain unit are all indicative of an absence of peat. This area will require further assessment post-felling. Contributory factors to a large-scale peat slide at proposed turbine locations indicated a low risk. There was no evidence of previous instability, no hydrological indicators or other key factors noted. Further probing information at this location would not increase the precision of the risk assessment until the post felling phase is reached at which point pre-construction ground investigation would be the logical point at which to gather additional geotechnical information. Assuming a worst-case score for peat depth in the risk assessment model at this location does not increase the risk category above 'low' due to the absence of other contributory factors and the significant distance for the nearest watercourse receptor (>400m).

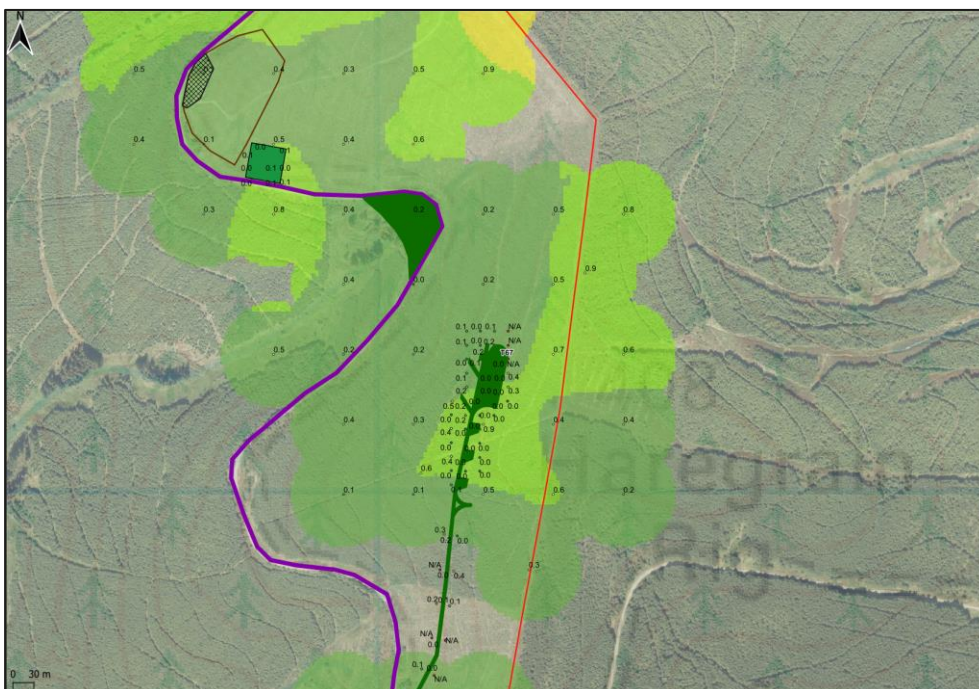
Based on this information the location of T67 was not initially prioritised for detailed peat probing as it does not represent a location from where there is a significant impact potential from peat slide. Across the surrounding terrain and in particular on the same slope system there is no continuous deep peat and contributory factors at proposed turbine locations indicated low risk from peat slide. Recent felling activity has had no detectable impact on stability based on the aerial image and last stage of detailed site assessment. At this time of the survey Q1 2020; there was dense forestry recorded at the turbine location which would have further hindered detailed probing. The additional detailed probing collected at this location confirmed the risk category as 'low' due to the absence of other contributory factors and the significant distance for the nearest watercourse receptor (>200m).

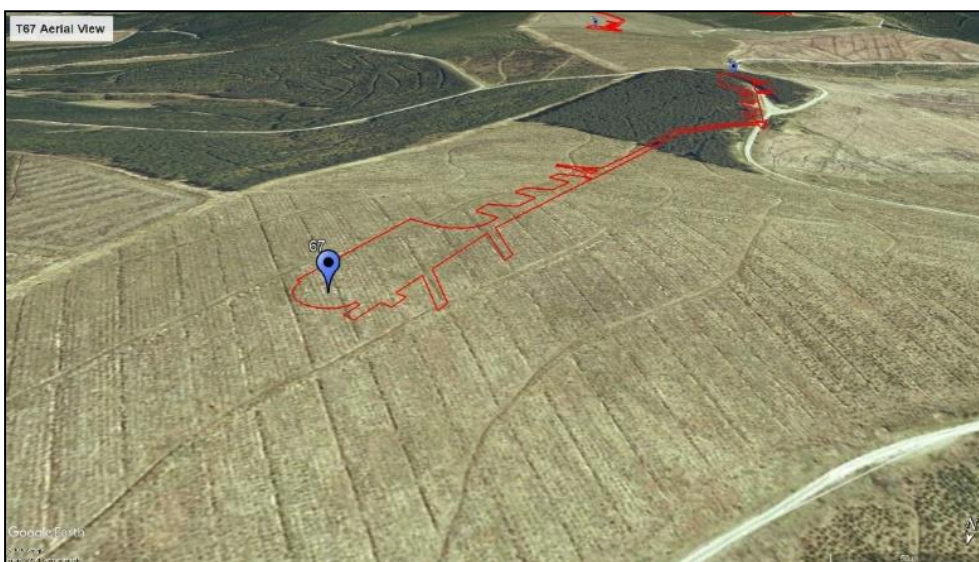
- Risk Category – **Low/Negligible**
- Peat Depth at Proposed Turbine Foundation Infrastructure - 0.1m (Peat Absent) recorded by 100m grid survey.
- Mean Peat Depth Surrounding Area – Peat soil thickness: mean depth 0.4m and likely represents a shallow mineral soil with isolated peat pockets
- Terrain 9° terrain slope angle

**T67 - Probe Depths and Elevation Contours (2m interval) with 3D terrain view for wider context (note updated imagery shown now clear fell condition across this location, dense forestry present at time of initial survey)**

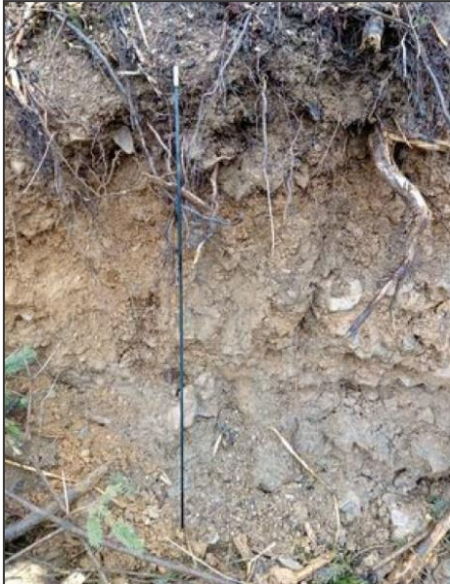
Photo at existing forestry road cutting south-east from Borrow Pit N5. No peat was visually present with mixed glacial subsoils dominant at this location.
